GEOTECHNICAL INVESTIGATION BLOCK 30 MISSION BAY San Francisco, California

Alexandria Real Estate Equities, Inc. San Francisco, California

> 17 October 2007 Project No. 4086.16

Proposed Biotechnology Development

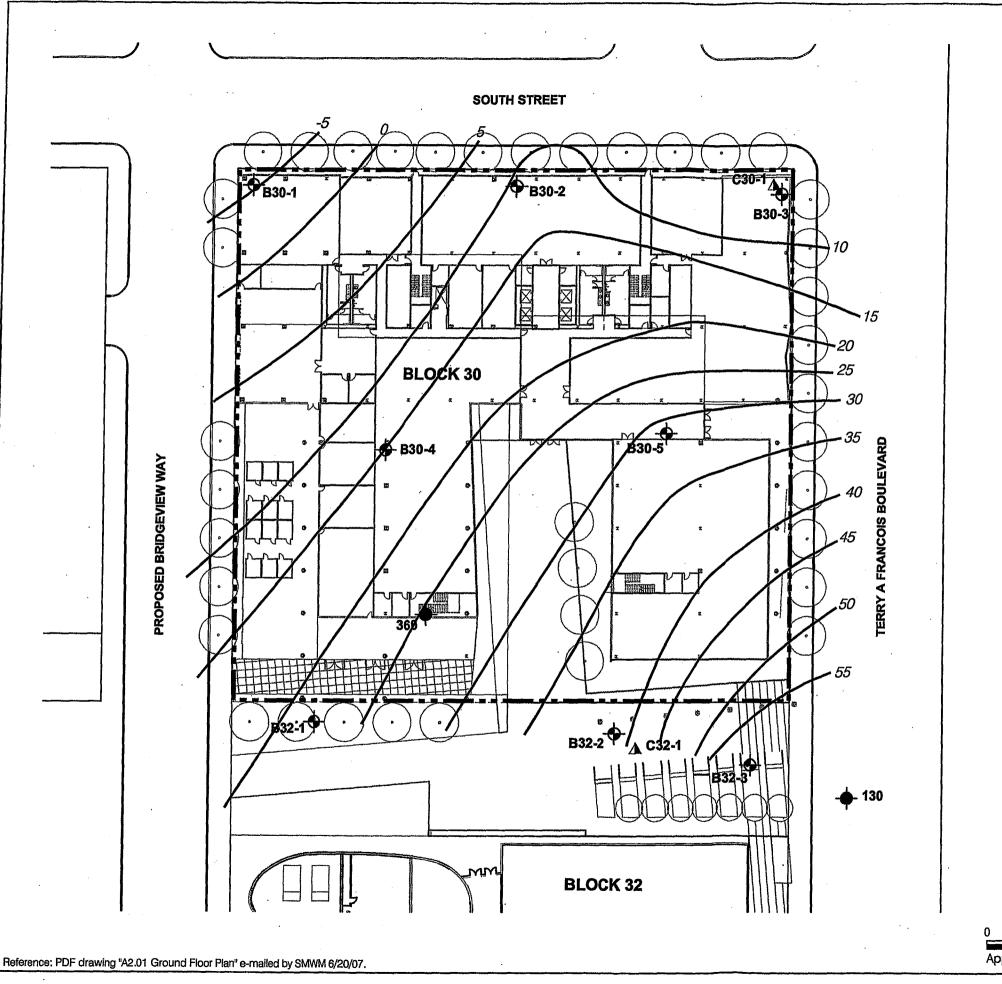
EXPLANATION

Estimated top of bedrock elevation contour,
San Francisco City Datum plus 100 feet

Note: see text regarding driving behavior in serpentinite rock

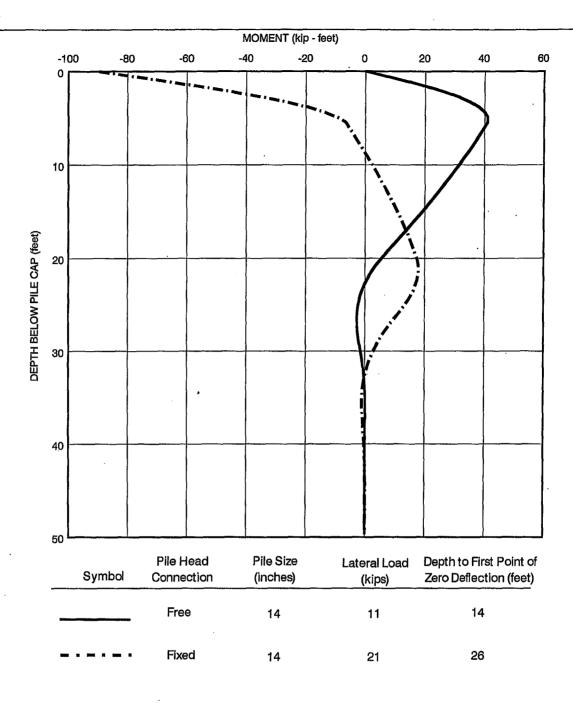
Figure 11

Notes for Figure:

- The profiles shown are for a single, square reinforced concrete pile with a maximum pile head deflection of 0.5 inch and an axial compressive load of 250 kips.
- 2. To account for group effects, the lateral load capacity of the pile group should be multiplied by the factor shown on Figure 13a and 13b. However, moment profile used to check individual piles in a group should be for the unfactored load.
- 3. Assumes there is no applied moment at the pile head.
- 4. Assumes site has not been improved to mitigate against liquefaction.
- 4. Assumes pile cap depth of five feet below bottom of floor slab.
- 5. Passive resistance of pile caps has not been included.

The lateral capacity of piles will be significantly increased if the potential for liquefaction is mitigated, as stated in Section 8.2. We have calculated the lateral capacity based on 1/2-inch lateral deflection at the top of pile for 14-inch-square prestressed, precast concrete piles with fixed and free head for two conditions: "With Liquefaction" and "No Liquefaction." The "With Liquefaction" case applies if the site is not improved, whereas the "No Liquefaction" case is for piles in areas of the site that have been improved. The lateral load for each case and the moment verses depth profiles for 1/2 inch of lateral deflection and vertical load of 250 kips are presented on Figures 11 and 12. Our analysis assumes pile caps will extend approximately five feet below the floor slab.

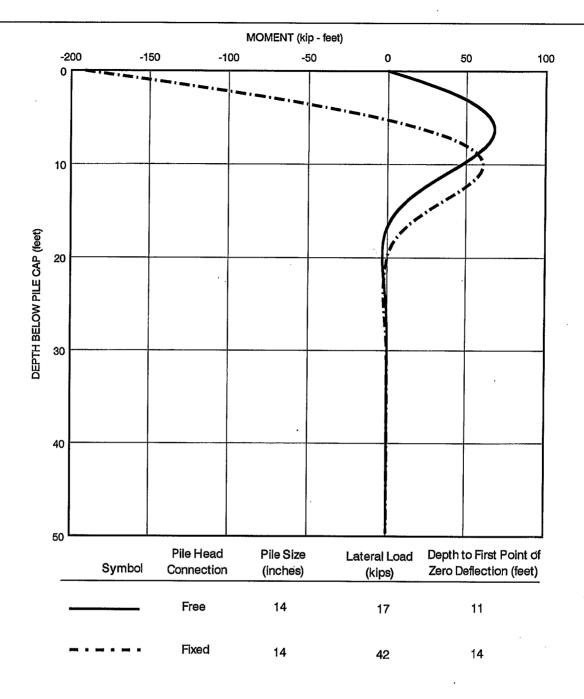
12

Notes for Figure:

- 1. The profiles shown are for a single, square reinforded concrete steel pile with a maximum pile head deflection of 0.5 inch and an axial compressive load of 250 kips.
- 2. To account for group effects, the lateral load capacity of the pile group should be multiplied by the factor shown on Figure 13a and 13b. However, moment profile used to check individual piles in a group should be for the unfactored load.
- 3. Assumes there is no applied moment at the pile head.
- 4. Assumes site has been improved to mitigate against liquefaction.
- 4. Assumes pile cap depth of five feet below bottom of floor slab.
- 5. Passive resistance of pile caps has not been included.

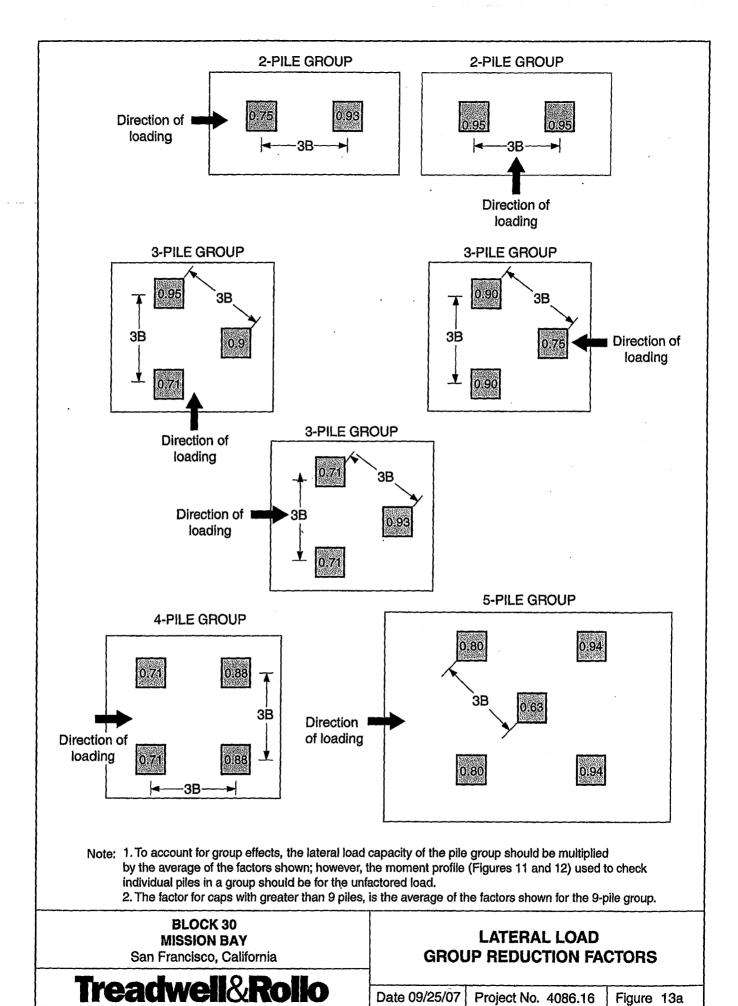
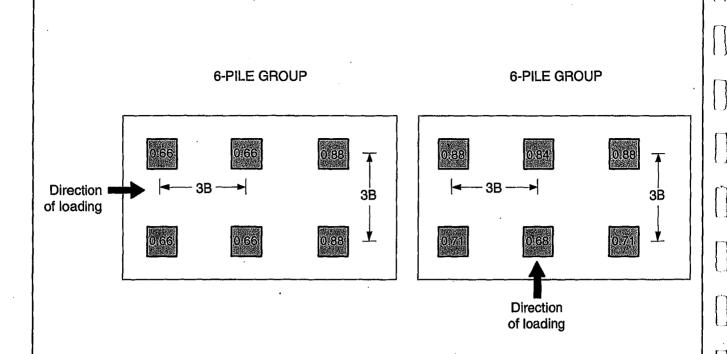
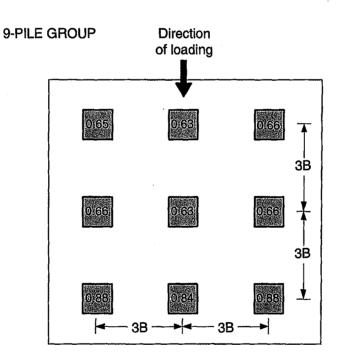
Date 09/25/07 Project No. 4086.16 Figure 13b

Note: 1. To account for group effects, the lateral load capacity of the pile group should be multiplied by the average of the factors shown; however, the moment profile (Figures 11 and 12) used to check individual piles in a group should be for the unfactored load.

2. The factor for caps with greater than 9 piles, is the average of the factors shown for the 9-pile group.

The lateral capacities are for a single pile only. To account for group effects, the lateral load capacity of a single pile should be multiplied by the appropriate reduction factors shown on Figure 13. The reduction factors are based on a minimum pile spacing of three widths. The moment profile for a single pile with an unfactored load should be used to check the design of individual piles in a group.

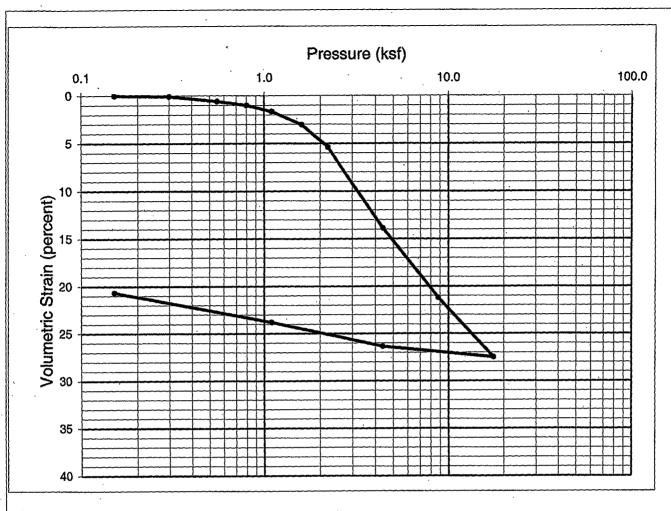
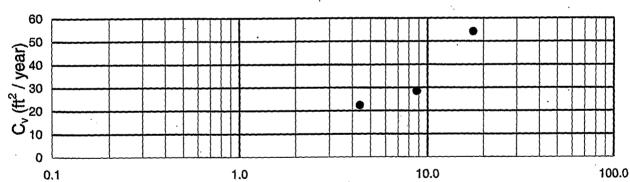
Date 09/26/07 Project No. 4086.16 Figure B-1

st .	After Test			Test	Before		Condition		ube	Shelby T	Sampler Type:	
3 %	42.3	Wf	%	58.6	Wo	ontent	Water C	1.00	leight (in)	2.41	Diameter (in)	
4	1.14	ef		1.66	eo	io	Void Rat	psf	, 1,700	ressure, p	Overburden Pr	
0 %	100	Si	%	95	So	on	Saturation	psf	1,900	essure, po	Preconsol. Pre	
9 pcf	79	Ya	pcf	63	Ya	sity	Dry Den	,	0.26	Ratio, C _{εο}	Compression I	
d)	(assumed)	2.70	G_s						0.04	Ratio, C _{er}	Compression I	
			@ 28'	B30-1	е	Source			H), gray	CLAY (C	Classification	
							BLOCK 30 - MISSION BAY					
	EPORT	est r	N TE	DATIO	ONSOL	C	San Francisco, California					
	EPORT	EST R	N TE	DATIO	ONSOL	С	BLOCK 30 - MISSION BAY

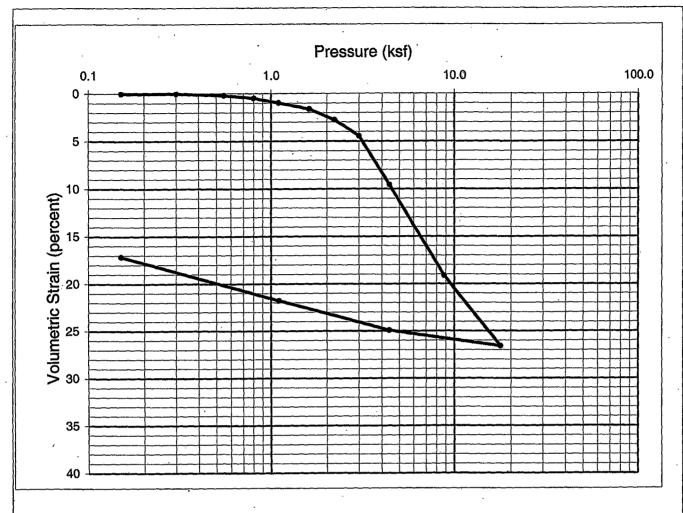
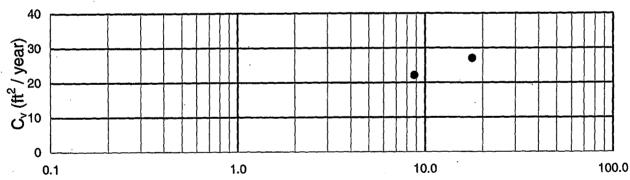
09/26/07 Project No. 4086.16 Figure B-2

Sampler Type: Shelb	y Tube			Condition		Befor	e Test			After Test	
Diameter (in) 2.41	Heig	ght (in)	1.01	Water Cor	ntent	Wo	63.4	%	Wf	47.7	%
Overburden Pressure	e, p _o	1,800	psf	Void Ratio)	e _o	1.73		e _f	1.29	
Preconsol. Pressure,	p _c	2,100	psf	Saturation	l	So	99	%	S _f	100	%
Compression Ratio,	O _{ec}	0.31		Dry Densit	ty	Ya	62	pcf	γ _d	74	pcf
Compression Ratio,	$C_{\epsilon r}$	0.05						G _s	2.70	(assumed)	
Classification CLAY	(CH)	grav			Sourc	e	B30-3	@ 24'

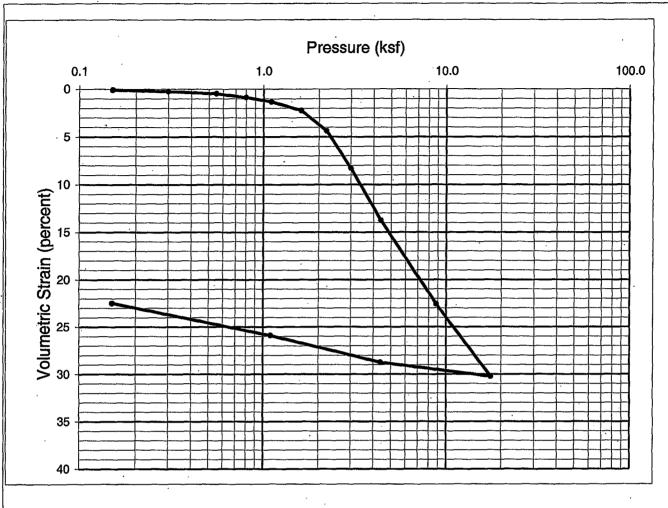
Date 09/26/07 Project No. 4086.16 Figure B-3

Sampler Type: Shelby Tu	эе		Condition	Befo	re Test		After Test	
Diameter (in) 2.41 H	eight (in)	1.01	Water Content	Wo	72.0 %	Wf	48.3	%
Overburden Pressure, po	2,550	psf	Void Ratio	e _o	1.96	e _f	1.30	
Preconsol. Pressure, pc	2,600	psf	Saturation	S。	99 .%	S _f	100	%
Compression Ratio, C _{εc}	0.29		Dry Density	γ _d	57 pcf	Ya	73	pcf
Compression Ratio, C _{εr}	0.05				G _s	2.70	(assumed)	
Classification CLAY (CH), gray	.,,,,,,,,,,,,,,,,,,,,,,,,,,,,,,,,,,,,,,	. Sc	urce	B30-3 @ 44'	· · · · · · · · · · · · · · · · · · ·

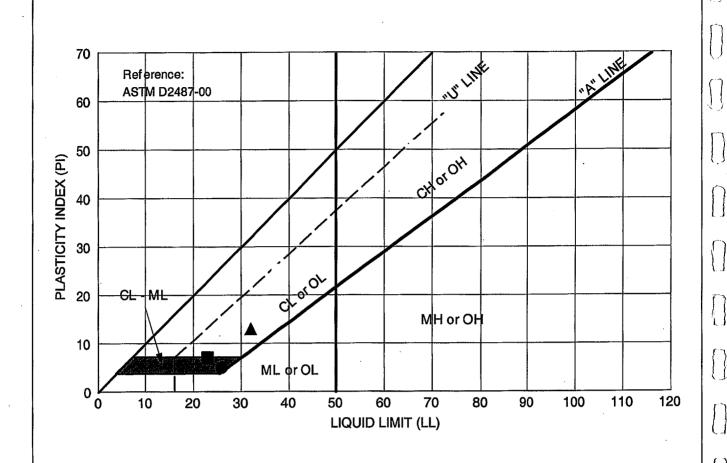
PLASTICITY CHART

Symbol	Source	Description and Classification	Natural M.C. (%)	Liquid Limit (%)	Plasticity Index (%)	% Passing #200 Sieve
•	B30-1 at 3 feet	SANDY SILT CLAY with GRAVEL (CL-ML), olive-gray		26	5	
	B30-2 at 10 feet,	CLAYEY SAND with GRAVEL (SC), green-gray		32	13	
	B-30-5 at 11.5 feet	SANDY SILTY CLAY (CL-ML), gray		23	7

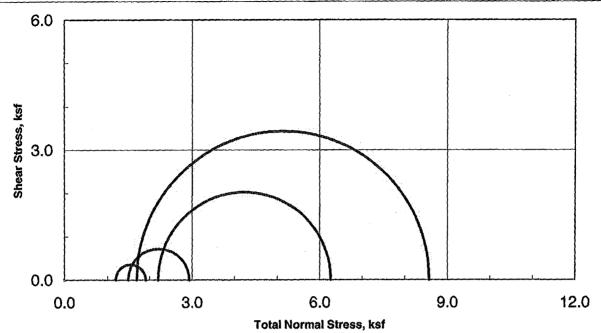
Unconsolidated-Undrained Triaxial Test ASTM D-2850

Stress-Strain Curves	Sample 1 Sample 2
	Sample 3
8.00	Sample 4
7.00	
6.00	
5.00	
4.00	
Deviator Stress, ks	
2.00	
1.00	**************
0.00	
)	10.0 15.0 20.0 rain, %
<u></u>

S	ample Date		
		2	3	4
Moisture %	58.1	25.5	63.8	22.3
Dry Den,pcf	65.5	99.7	61.8	105.1
Void Ratio	1.572	0.691	1.725	0.604
Saturation %	99.7	99.6	99.8	99.7
Height in	6.02	5.00	6.01	5.01
Diameter in	2.86	2.43	2.86	2.40
Cell psi	8.3	15.3	10.4	11.8
Strain %	3.40	14.10	2.80	14.70
Deviator, ksf	0.720	4.061	1.450	6.896
Rate %min	1.00	1.00	1.00	1.00
in/min	0.060	0.050	0.060	0.050
Job No.:	010-1041a			
Client:	Treadwell	& Rollo		
Project:	Block 30/E	llock 32 - 4	086.16/.17	
Boring:	B30-1	B30-2	B30-4	B30-4
Sample:				
Depth ft:	28	59.5	39	54.0
	Visual	Soil Descr	iption	
Sample #				
1	Gray CLAY			
2	Olive Brow	n CLAY w/ S	Sand	
3	Gray CLAY	′		
4	Olive Brow	n CLAY w/ S	Sand	
Remarks:

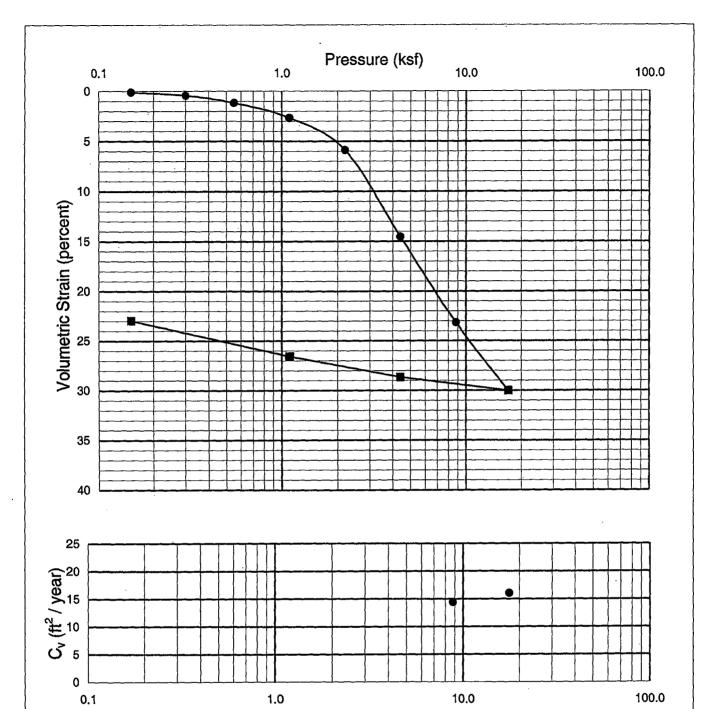
Sampler Type: Shelby Tub) e		Condition			Befo	ore Test		I	After Test	·
Diameter (in) 2.41 He	ight (in)	1.00	Water C	ontent	,	W _o	70.4	%	Wf	48.1	%
Overburden Pressure, po	1,600	psf	Void Rat	tio		e _o	1.91		ef	1.30	
Preconsol. Pressure, pc	1,900	psf	Saturation	on	,	S _o	99	%	S _f	100	%
Compression Ratio, C _{εc}	0.64		Dry Den	sity	,	γ_d	58	pcf	Ya	48	pcf
Recompression Ratio, Cer	0.04							G _s	2.70	(assumed)	
Classification CLAY (CH), dark gray to gray				S	Source		B32-1	@ 16.	.5 feet		
BLOC	K 32										
San Francisco, California				CON	NSC	LIDATIO	N TI	EST R	EPORT		
Treadwe	1121	3		Date	08/03	/07	Project No.	40	086.17	Figure B	 i-1

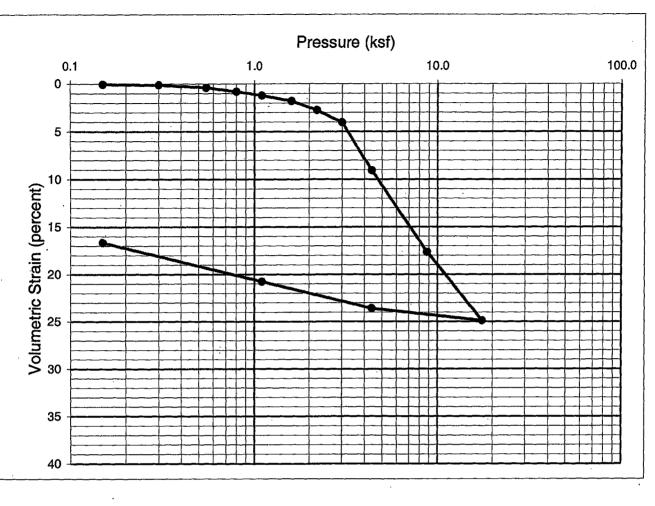
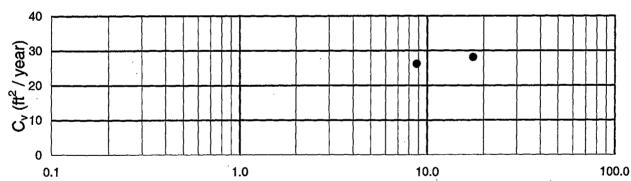
08/03/07 Project No. 4086.17 Date B-2 Figure

Sampler Type: She	lby Tu	ıbe		Condition	Befor	e Test		After Test	
Diameter (in) 2.	42 H	leight (in)	1.01	Water Content	Wo	57.6 %	Wf	43.3	%
Overburden Press	ıre, p _o	1,900	psf	Void Ratio	e _o	1.56	ef	1.17	
Preconsol. Pressu	e, p _c	2,900	psf	Saturation	So	100 %	S _f	100	%
Compression Ratio	, C _{εc}	0.29		Dry Density	γ _a	66 pcf	γ _d	78	pcf
LL	PI			PI		G _s	2.70	(assumed)	
Classification CL	Y (CL	.), gray			Source	B32-1 @ 24'

Classification CLAY (CL), gray

CONSOLIDATION TEST REPORT

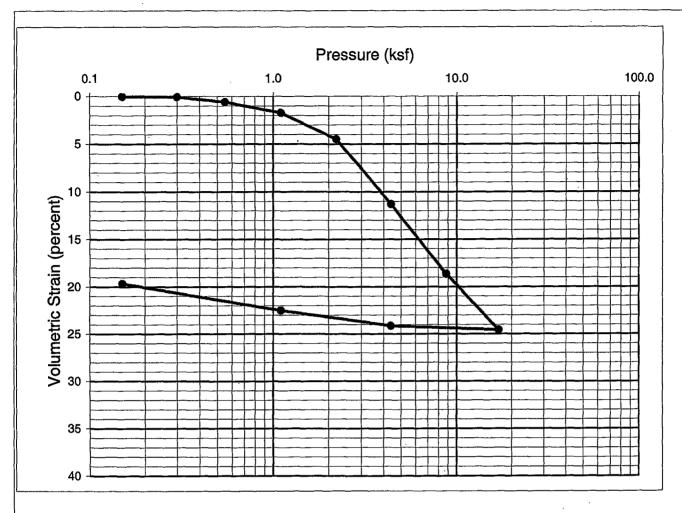
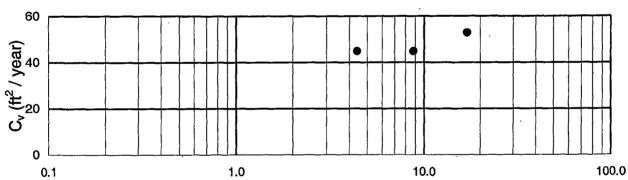
Date 08/03/07 Project No. 4086.17 Figure B-3

Sampler Type: Shelby Tu	be		Condition	Befor	e Test			After Test	
Diameter (in) 2.41 H	eight (in)	1.00	Water Conten	t W _o	50.9	%	Wf	35.9	%
Overburden Pressure, po	1,600	psf	Void Ratio	e _o	1.39		ef	0.97	
Preconsol. Pressure, pc	2,000	psf	Saturation	S _o	99	%	S _f	100	%
Compression Ratio, C _{εc}	0.25		Dry Density	$\gamma_{\rm d}$	71	pcf	γ _d	86	pcf
LL PL			PI			G _s	2.70	(assumed)	
Classification CLAY (Ch	l), gray			Source	B32-3 @	24'

BLOCK 32 - MISSION BAY EAST San Francisco, California

CONSOLIDATION TEST REPORT

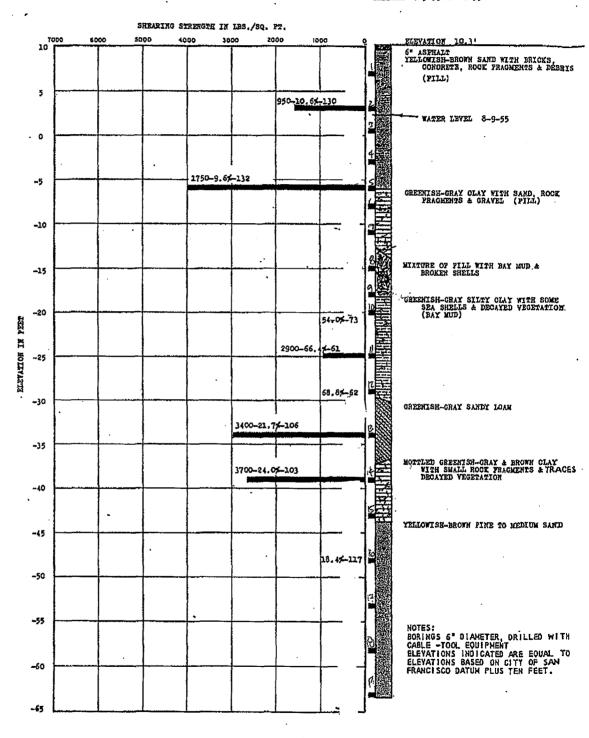
BORING I

LOG OF BORING

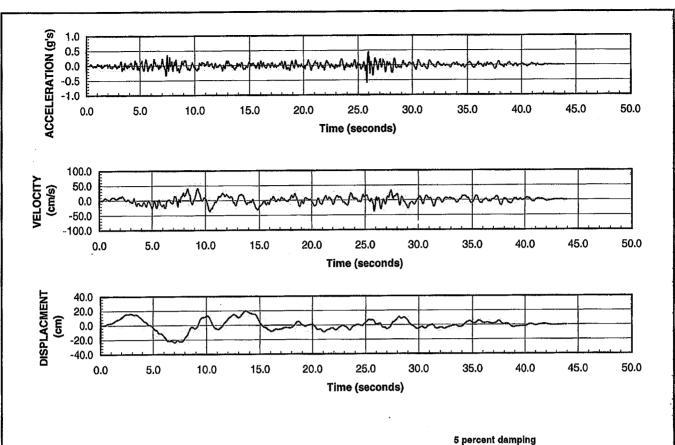
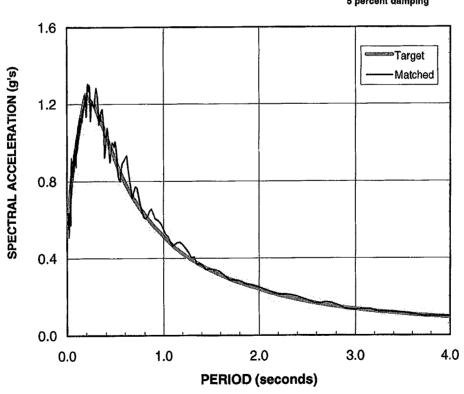
Date 07/30/07 | Project No. 4086.16 | Figure E-5

DBE MATCHED ROCK TIME HISTORY AND RESPONSE SPECTRUM 1992 LANDERS EARTHQUAKE JOSHUA TREE - 0 DEGREE
