GEOTECHNICAL INVESTIGATION BLOCKS 29, 30, 31, AND 32 PUBLIC IMPROVEMENTS MISSION BAY San Francisco, California

Catellus San Francisco, California

7 April 2008 Project No. 3347.01

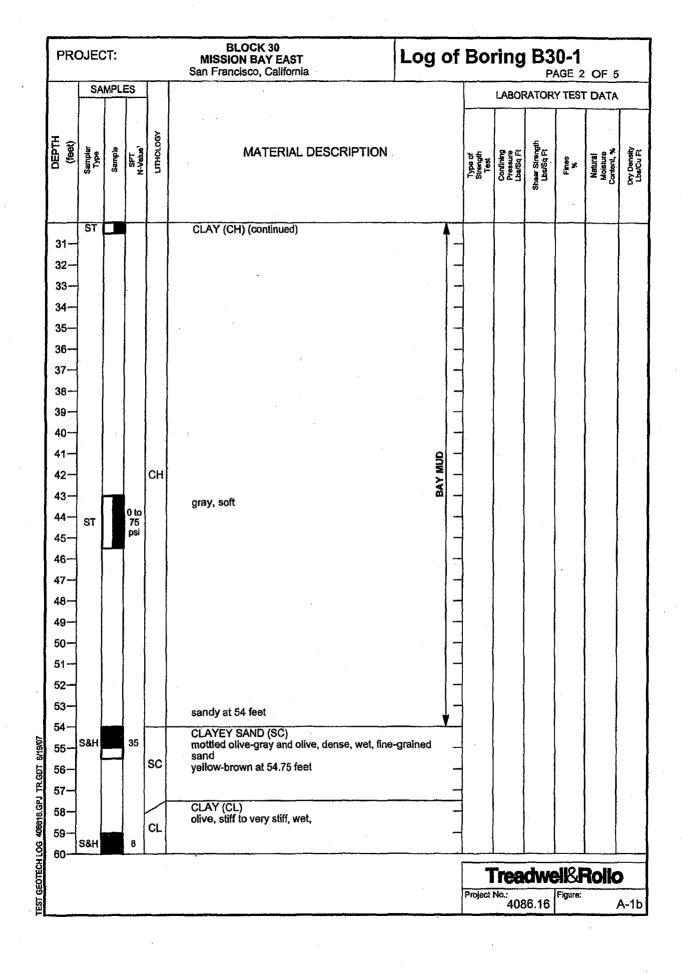
25— 26— 27— 28— 29— 30—								L	Trea	dwe		Polic)
								Project	No.: 408	36.16	Figure:		A-1a

PR	OJE	CT:			BLOCK 30 MISSION BAY EAST San Francisco, California	Log	g o	f Bo	ring		80-1 AGE		5
Bor	ing lo	ation	า:	See S	lite Plan, Figure 2			Log	ged by	L. S	Splitter		
	e star			5/6/0				_					
	ling m				y Wash								
					40 lbs./30 inches Hammer type: Rope and C				LABO	RATOF	RY TES	T DATA	
	Sampler: Sprague & Henwood (S&H), Standard Penetration Test (SPT), Shelby Tube (ST)												
DEPTH (feet)	Sampler		SPT N-Vakue	LTHOLOGY	MATERIAL DESCRIPTION	· \		Type of Strength	Confining Pressure Lbs/Sq Ft	Shear Strength Lbe/Sq Ft	Fines	Natural Moisture Content, %	Dry Density Lbs/Cu Ft
<u> </u>	18.	0	2	-	Ground Surface Elevation: 100.6 fe	et ²			ļ	v	 		
1-	4			-	6 inches aggregate base	<u></u>		=		ł			
2-	4			sc	CLAYEY SAND (SC) yellow-brown, medium dense, molst, with bri	ck	Ţ	4	-			{	
3-	 S&H		19	\vdash	fragments SANDY SILTY CLAY with GRAVEL (CL-ML)	· · · · · · · · · · · · · · · · · · ·	\dashv	╡	1				ļ

4-	Joan		19	CL-	olive-gray, very stiff, moist, with brick fragme LL = 26, PI = 5	nts	- 1	_	1				
5-		<u>_</u> _		ML	20,11			_					
6-	SPT	4	17		SAND (SP)		+	╡					
7-]	_	1		olive, medium dense, moist, with glass and g	ravel		_					İ
8-	SPT		4	SP	gray-brown, very loose, with brick, rock in sh count low because pushed into clay	oe, blow	,						
9-		 			CLAY (CH)		一	-					
10-			١.		gray, very soft, wet			-					
11-	S&H		1					-	1				
12-	1							-					
13-	1				gray, trace sand			-					
14-	ST		0 to				- {	-	-				
15-			psi					-]		
16-								-{		ļ			
17-							- 1	-	1				,
18—								-		•			
19-							M CD	4					
20-				СН			BAY	-					
21-							"	4					
22-								4]		
23-								_					
24-							.	-			,		٠.
25								4					
26~					shells at 26 feet		.	_			'		
27-				1			.	1					
28-							1.	1					
29-	ST		0 to 100		blue-gray, soft Consolidation Test, see Figure B-1			TxUU	1,200	360		58.6	63
30-			psi				<u> </u>				<u> </u>

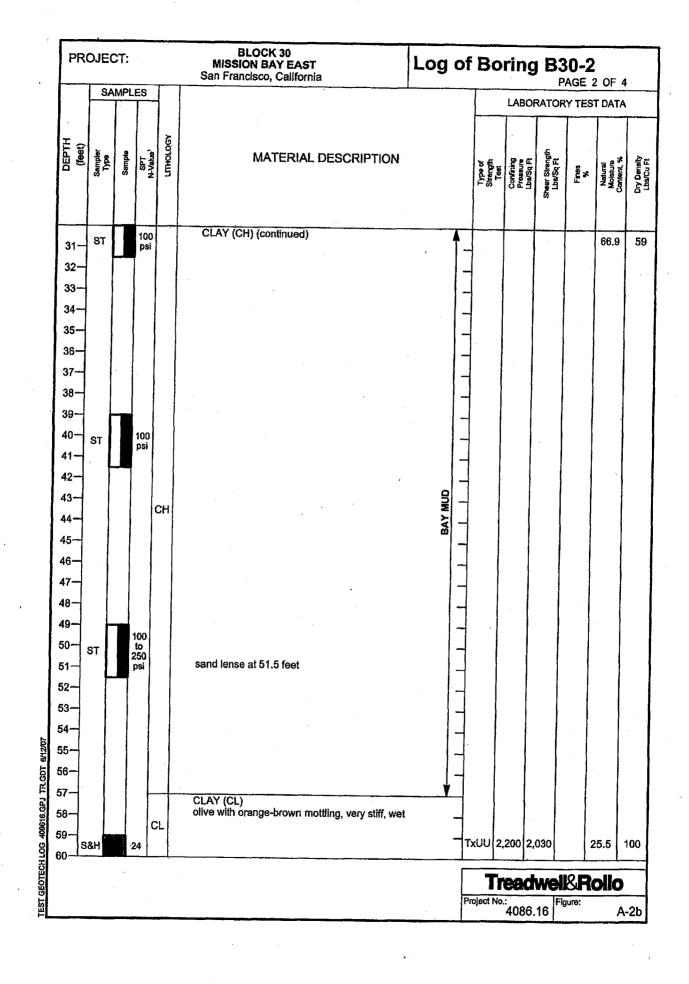
PR	OJE	CT:			BLOCK 30 MISSION BAY EAST San Francisco, California	Log	of	Во	ring			OF 4				
Bor	ing lo	cation	ı: S	See S	Site Plan, Figure 2			Logged by: J. Wong								
Dat	e starl	ted:		5/3/0	Date finished: 5/3/07											
Dril	ling m	ethod	l: F	Rotar	y Wash											
			_		40 lbs./30 inches Hammer type: Rope a			1	LABOR	ATOR	Y TEST	DATA				
Sar		Spra MPLI			vood (S&H), Standard Penetration Test (SPT), Shelby 1	ube (ST)			207	5	<u> </u>	. *	بير کے			
DEPTH	Sampler		SPT N-Value	LITHOLOGY	MATERIAL DESCRIPTION			Type of Strength Test	Confining Pressure Lbe/Sq Ft	Shear Strength Lbs/Sq Ft	Figures %	Natural Moisture Content, %	Dry Density Lbs/Cu Ft			
<u> </u>	S	100	"ź	5	Ground Surface Elevation: 100 2 inches asphalt concret over	.4 feet 2				<i>5</i> 5	 					
1-	4				12 inches aggregate base			}								
2-	1	1			SAND with GRAVEL (SP) olive-brown, medium dense, moist, with	angular to	^ _									
3-	J				subangular gravel, traces of brick and S fragments	erpentinite	_

4-]S&H		17	SP	nagments .		_	,								
	1	Γ														
5~	SPT		12		higher brick content, trace fines		-						•			
6-	1		,_		CLAY with SAND and GRAVEL (CH)	 	+-	1								
7-	1				dark gray, stiff, moist		-									
8- 9-	SPT		9	СН	olive clay was observed from cuttings at ♀ (5/3/07 at 7:55 am)	t 88 feet	-									
10-					CLAYEY SAND with GRAVEL (SC)		+=	1								
	S&H		7	2	green-gray, loose, wet, serpentinite frag LL = 32, Pl = 13	ments					17.6	13.0				
11-	1				LL - 02, 11 - 10		-] .								
12-	SPT		48	sc	gray, dense		_ _	1								
13-	1					Ē	네 -					·				
14-	\exists															
15-	-				SANDY CLAY with GRAVEL (CH) dark gray, stiff, wet, with angular to sub-	angular gravel.	-									
16~	4			Ì	and Shale fragments	angalar gravon	<u>-</u>									
17-	SPT		40				-									
18~	SPI		13													
1						•	_	}								
19-	SPT		14	СН							,					
20~							-]								
21-	1						-									
22-	1						. -

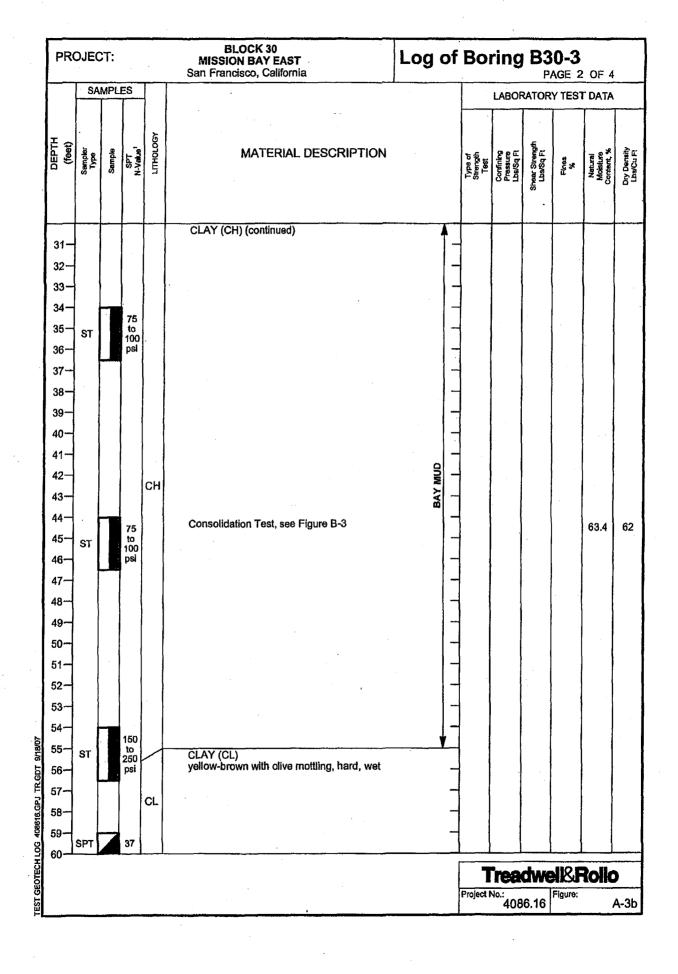
PRO	OJE	CT:			BLOCK 30 MISSION BAY EAST San Francisco, California	g	of	Bo	ring			OF 4	- 	
	Bori	ng loc	ation	:	See S	Site Plan, Figure 2				Logg	ed by:	J. W	ong/		
	Date	start	ed:		5/2/0	7 Date finished: 5/2/07					-				
		ing m				y Wash		·							
						40 lbs./30 inches Hammer type: Rope and C		·			LABOF	RATOR	Y TEST	DATA	
	Sam		<u>_</u>		T	wood (S&H), Standard Penetration Test (SPT), Shelby Tube (ST)					£	Γ		
	DEPTH (feet)		Sample	SPT C	Г ТНО <u>Г</u> ОСУ	MATERIAL DESCRIPTION				Type of Strength Test	Confining Pressure Lbs/Sq Ft	Shear Strengt	Fines	Natural Moisture Content, %	Dry Density Lbs/Cu Ft
		95	ß	ω ≥	5	Ground Surface Elevation: +100.3 fe	et²					<i>&</i>	ļ		6-
	1					2 inches asphalt concret over 12 inches aggregate base		7	r=

-						12 inches aggregate base CLAYEY SAND with GRAVEL (SC)	ulas ša								
ı	2-				İ	olive-brown, medium dense, moist, with ang subangular gravel	uiar to		-					,	
	3-	S&H		26	sc				7						
	4-	1			30	•			-						
	5-	1				olive-gray, with serpentinite fragments			-						
	6-	SPT	1	17		onve-gray, with surportainte nagmente			_

-	7-		-			SANDY CLAY with GRAVEL (CL)									
ſ				l	CL	olive-gray, stiff, moist				·					
	8-	SPT	4	9		•								į	
1	9	İ				SAND with CLAY and GRAVEL (SP-SC)			-						
ı	10					gray, medium dense, wet (5/2/07 at 8:15 am)		FILL	. –						
ı	11-	S&H		18	en.			iL.					6.0	11.0	
١	12-	SPT		14	SP-				_						
	13-	" '		'`											
ı	14-								_						
						CLAYEY GRAVEL with SAND (GC)									
	15—					olive-gray, medium dense, wet

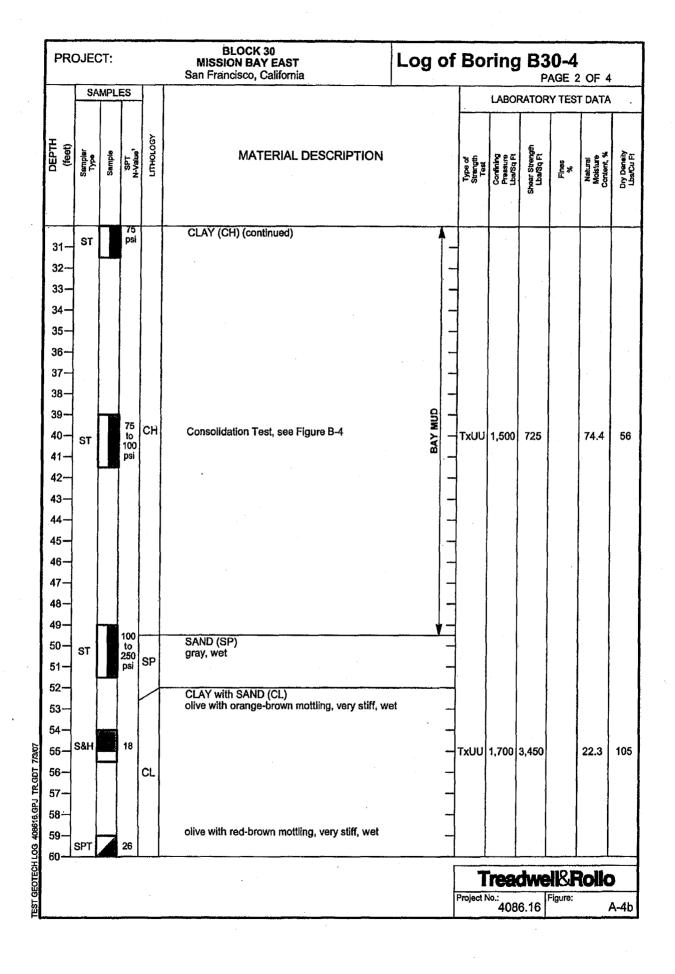
-								7	rea	dwe	18	Polic	
								Project I	No.:		Figure:		
L								<u> </u>	408	6.16		/	4-4a

PRO	OJEC	CT:		*	BLOCK 30 MISSION BAY EAST San Francisco, California	Log	of	Bo	ring	B3	0-4 AGE 1	OF 4	
Borir	ng loc	ation	1:	See S	Site Plan, Figure 2	<u></u>		Logg	jed by:	J. W			
Date	start	ed:		5/5/0	7 Date finished: 5/5/07								
Drilli	ng me	ethod	l: [Rota	y Wash			ļ					
					40 lbs./30 inches Hammer type: Rope and C			-	LABOR	ATOR	Y TEST	DATA	
Sam				1	wood (S&H), Standard Penetration Test (SPT), Shelby Tube (ST)				€.		Π.	
DEPTH (feet)		MPLI		50	MATERIAL DESCRIPTION			Type of Strength Test	Confining Preseure Lbs/Sq Ft	Streng	Fines 8	Natural Moisture Content, %	Dry Density Lbs/Cu Ft
DEPTI:	Sampler Type	Sample	SPT N-Value	гтногост	Ground Surface Elevation: 100.4 fe	nt 2		F. 85 F	823	Shear Strangth Lbs/Sq Ft	<u> </u>	288	25

-	Ē	3 inches asphalt concret over	Et							
1-					12 inches aggregate base CLAYEY SAND (SC)								
2-				sc	olive-brown, medium dense, moist		1 -	-					
3-	S&H		15		SAND (SP)	· · · · · · · · · · · · · · · · · · ·							
4-				SP.	yellow-brown, medium dense, moist, fine-gra	ined	-						
5-				0.	saiid								
6-	SPT		13		CLAY with GRAVEL (CH)		+-						
7-		4			gray, stiff, moist		_						
8-				СН	∑ (5/5/07 at 8:40 am)		1_						
9	SPT		в]					
					green with dark green mottling, medium stiff, angular Serpentinite gravel	wet, with	1						
10-	S&H		4	GC	CLAYEY GRAVEL (GC)		┪-						
11-			Í		green-gray, loose, wet, with Serpentinite CLAYEY SAND with GRAVEL (SC)								
12-	SPT		12		olive, medium dense, wet]-		İ				
13-				sc		Ī	넴 ~						
14—							-						
15—					SAND with CLAY and GRAVEL (SP-SC)		+						
16					gray, medium dense, wet		-						
17—	SPT		13										
18—							-						
19—					vendena Arlana		-

20-	SPT		4	SP-	very loose to loose		_				6.7	19.9	
21-				sc			_						
22-		Ì			•		_						
23-													
				ļ	•								
24-							V						
25-					CLAY (CH)		A						
26-					gray, medium stiff, wet, with shell fragments	ć	- اد				-		
27—				СН			BAY MUL						
28-		- 1				2	<u>- ال</u> م					ļ	
29	e. [75			•]-	PP		750			
30—	ST		psi	1			Y	l

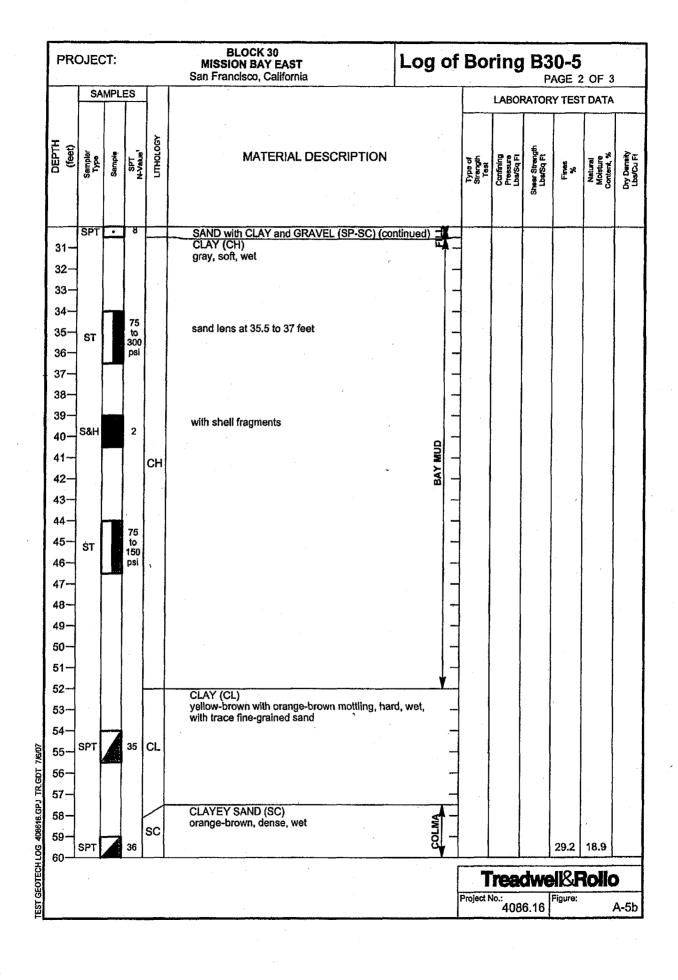
PR	OJE	CT:			BLOCK 30 MISSION BAY EAST San Francisco, California	Log	of	Bo	ring			OF 3	
Bori	ng loc	ation	ı; {	See S	Site Plan, Figure 2	·		Logg	ed by:	J. W	ong		***************************************
	e start												
	ing m							ļ	· · · · · · · · · · · · · · · · · · ·		· 		
<u> </u>									LABOR	KATOR'	Y TEST	DATA	
	ipler:	MPL		See Site Plan, Figure 2 5/4/07 Date finished: 5/4/07 Rotary Wash Op: 140 lbs./30 inches Hammer type: Rope and Cathead & Henwood (S&H), Standard Penetration Test (SPT), Shelby Tube (ST) MATERIAL DESCRIPTION Ground Surface Elevation: 100.3 feet 2 3 inches asphalt concret over 12 inches aggregate base and 4 inches concrete CLAYEY SAND with GRAVEL (SC) ollve-gray, medium dense, moist SC loose to medium dense, with brick fragments and Serpentinite (5/4/07 at 8:45 am) stiff, no brick SANDY SILTY CLAY (CL-ML) gray, stiff, wet LL = 23, Pl = 7 SAND with CLAY and GRAVEL (SP-SC) green-gray, medium dense, wet				00.00	riggi.		*	بر <u>چ</u>

DEPTH (feet)				507	MATERIAL DESCRIPTION			Type of Strength Test	Confining Pressure Lbs/Sq Ft	Shear Strength Lbs/Sq Ft	Fines	Natural Moisture Content, %	Dry Density Lbs/Cu Ft
出 等	Sampler Type	Sample	SPT N-Value	Ě	Ground Surface Elevation: 100.3 fe	et 2		[⊢ <i>®</i>	853	Shear	_	2≥0	문급
1-	-	-	-		3 inches asphalt concret over 12 inches aggregate base and								
2-	-		1		CLAYEY SAND with GRAVEL (SC)		A -	1		ı			
3-			۱.,		olive-gray, medium dense, moist		_	1					
4-	S&H		16				_						
5				sc			_			'			
1	SPT		10	1	loose to medium dense, with brick fragments	;							
6~							-						
7-	1]				
8-	SPT	4	8		CLAY with SAND (CH)	ments	-	1			i		
9-	1	-	}	СН	and Serpentinite		-						
10~	1				•] -]				
11-	S&H		11				-						
12-	SPT		11		gray, stiff, wet		_						
13-	SFI		'		LL = 23, Pl = 7		_	Į.					
14-						:	_						
15-					SAND with CLAY and GRAVEL (SP-SC)			}					
1					green-gray, medium dense, wet		딆_

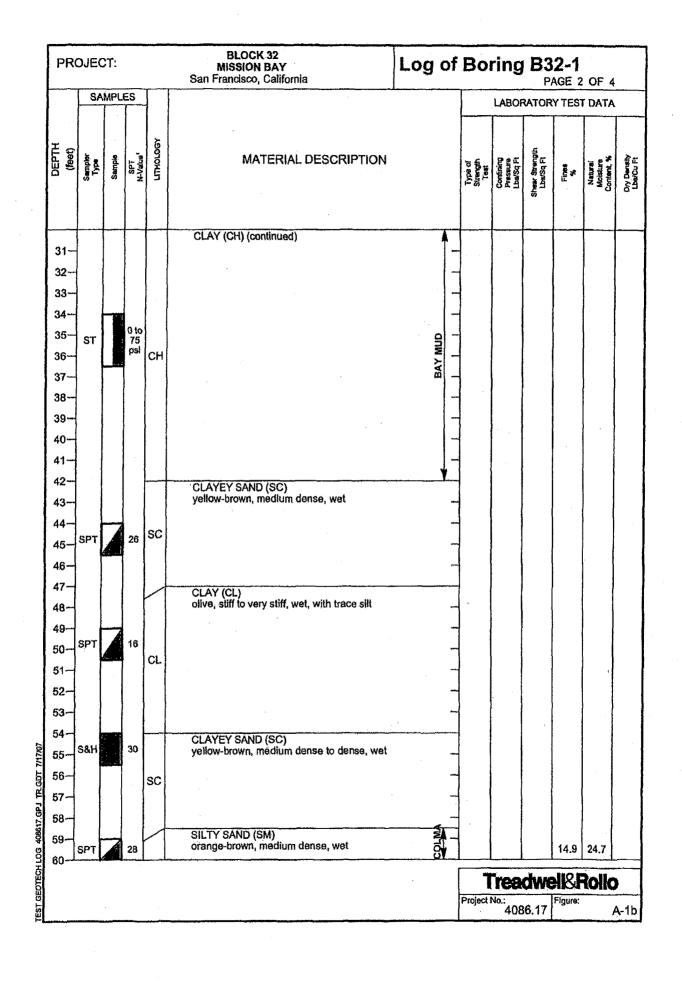
25- 26- 27- 28- 29- 30-							•					. 1	rea	dwe	181	Polic	•
5											Ī	Project N	10.: 408	6.17	Figure:		A-1a
<u> </u>											┸		700	~/		,

-	- 0	+	0	Ż	-	╀	Ground Surface Elevation: +105 fe CLAYEY SAND with GRAVEL (SC)	et*	, 		_		ļ	-	ļ		-
1							olive-brown, medium dense, moist trace brick and subangular gravel			• [`						
2	-									- (ļ			
3	S8	Н		13			LL = 20, PI = NP										
4	1	. [٦						
5	1	_			sc					긢	7						İ

6.	SF	'_		3		l	very loose			14.	\dashv				l	ļ	·
7.	4	L				l					\dashv				1		
8-	SF	т	A	7			loose, with serpentinite fragments				\dashv				25.9	13.7	
9-	-	H									-					1	
10-	-										-						
11-	_ S&	н		5	<u> </u>	-	CLAY (CH)			- Y	-						
12-	SP	_	7	5		,	gray, soft, wet, with shell fragments			T	-	-			1		
13-	ī	` 4				₽	. (4/30/07 at 1:40 pm)				4				1		
14-	_		l							- {	1						
15-	1	1	.												ŀ		
16-	1											- [
17-	1	r		50			Consolidation Test, see Figure B-1					TxUU	1,050	275		66.8	60
18-	97	- [to 75			•						l				
19-	1	L		psi													
1		Γ	\Box							9							
20-]			į	СН					BAY MU							
21-				į						BA BA	7						
22-	1										7		ļ				
23-	1										7						
24-	1	1		50			Consolidation Test, see Figure B-2				\dashv						
25-	 S1	1		to 75	.						7	Ì	1			57.6	66
26-	1	L		psi							7						
27-	1									1	\dashv	j					
28-	1		1								\dashv	ł	.				
29-	1										4	ļ	ļ				
30-	ــــــــــــــــــــــــــــــــــــــ				Ll							<u>.</u>			L

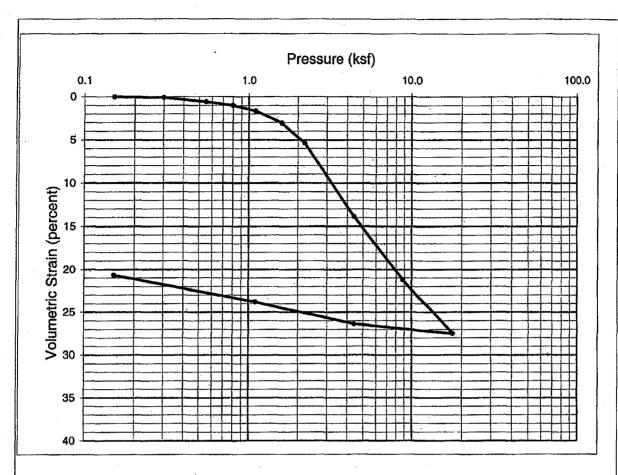
Date 09/26/07 Project No. 4086.16 Figure B-1

Sampler Type: Shelby Tu	Condition		Befo	re Test	After Test		
Diameter (in) 2.41 H	leight (in)	1.00	Water Content	Wo	58.6 %	Wf	42.3 %
Overburden Pressure, po	1,700	psf	Void Ratio	e _o	1.66	er	1.14
Preconsol. Pressure, pc	1,900	psf	Saturation	S _o	95 %	Si	100 %
Compression Ratio, $C_{\epsilon c}$	0.26	•	Dry Density	Ya	63 pcf	γ _d	79 pcf
Compression Ratio, Cer	0.04				G _s	2.70	(assumed)

CONSOLIDATION TEST REPORT

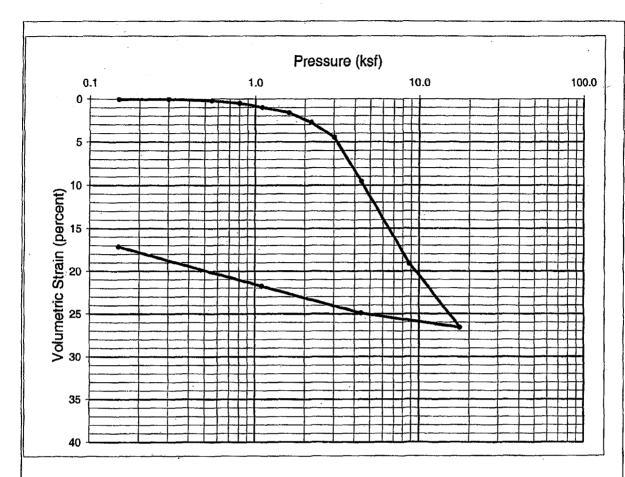
Date 09/26/07 Project No. 4086.16 Figure B-2

Sampler Type: Shelby Tube		Condition	Befo	re Test	After Test		
Diameter (in) 2.41 Height	(in) 1.01	Water Content	Wo	63.4 %	Wf	47.7 %	
Overburden Pressure, po 1,	800 psf	Void Ratio	e _o	1.73	e _i	1.29	
Preconsol. Pressure, p. 2,	100 psf	Saturation	So	99 %	Sf	100 %	
Compression Ratio, Cεο 0	.31	Dry Density	Ya	62 pcf	Ya	74 pcf	
Compression Ratio, Cer 0	.05			G _s	2.70	(assumed)

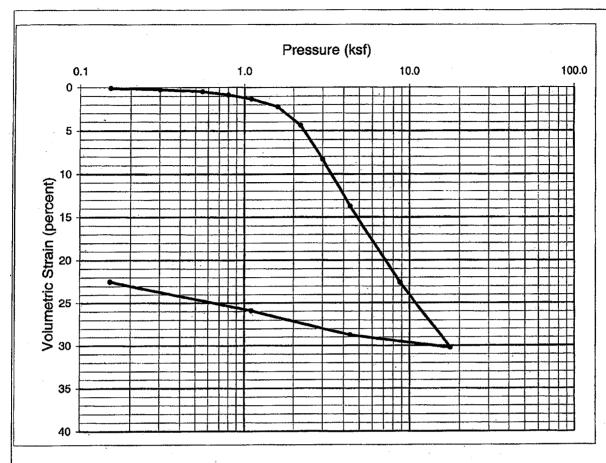
Date 09/26/07 Project No. 4086.16 Figure B-3

Sampler Type: Shelby T	ube		Condition	Befo	re Test		After Test	
	Height (in)	1.01	Water Conten	t W _o	72.0 %	6 Wf	48.3	%
Overburden Pressure, p	o 2,550	psf	Void Ratio	e _o	1.96	e _f	1.30	
Preconsol. Pressure, pc	2,600	psf	Saturation	S _o	99 %	6 S _f	100	%
Compression Ratio, C ₆₀	0.29		Dry Density	Ya	57 pi	of Ya	73	pcf
Compression Ratio, Cer	0.05				G _s	2.70	(assumed)	
Classification CLAY (C	H), gray			Source	B30-3 @ 4	44'

CONSOLIDATION TEST REPORT

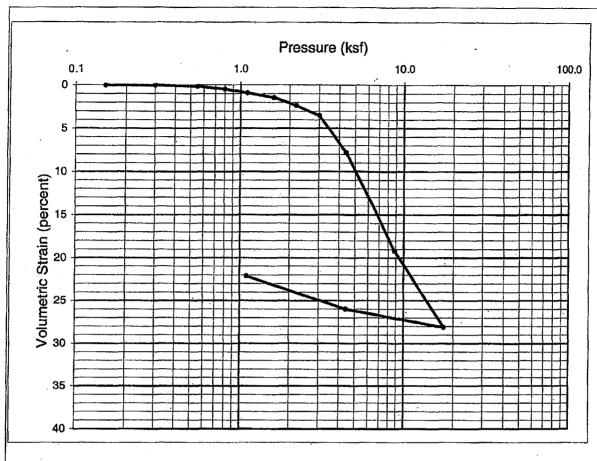
Sampler Type: Shelby T	ube		Condition	Befor	e Test		After Test	
Diameter (in) 2.41	Height (in)	1.01	Water Content	Wo	74.4 %	W _f	56.3	%
Overburden Pressure, p	。 2,450	psf	Void Ratio	e _o	2.02	e _f	1.52	
Preconsol. Pressure, pc	3,300	psf	Saturation	So	100 %	S _f	100	%
Compression Ratio, $C_{\epsilon c}$	0.35		Dry Density	Ya	56 pcf	γa	67	pcf
Compression Ratio, C _{εr}	0.06				G _s	2.70	(assumed)	
Classification CLAY (C	H), gray			Source	B30-4 @ 39

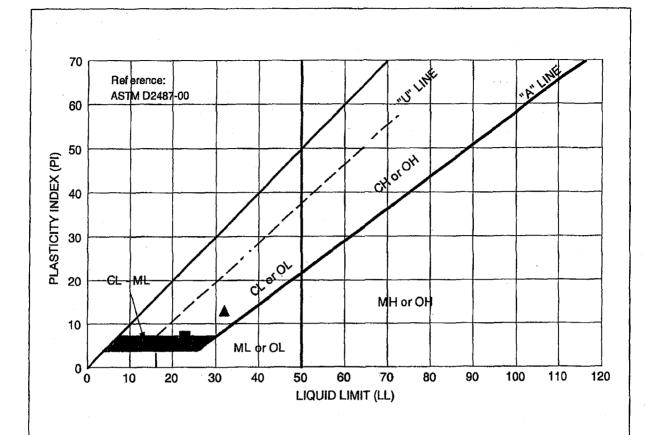
Date 09/25/07 Project No. 4086.16 Figure B-6

Symbol	Source	Description and Classification	Natural M.C. (%)	Liquid Limit (%)	Plasticity Index (%)	% Passing #200 Sieve
•	B30-1 at 3 feet	SANDY SILT CLAY with GRAVEL (CL-ML), olive-gray		26	5	
•	B30-2 at 10 feet	CLAYEY SAND with GRAVEL (SC), green-gray	••	32	13	
*	B-30-5 at 11.5 feet	SANDY SILTY CLAY (CL-ML), gray		23	7	
	·					
						İ

PLASTICITY CHART

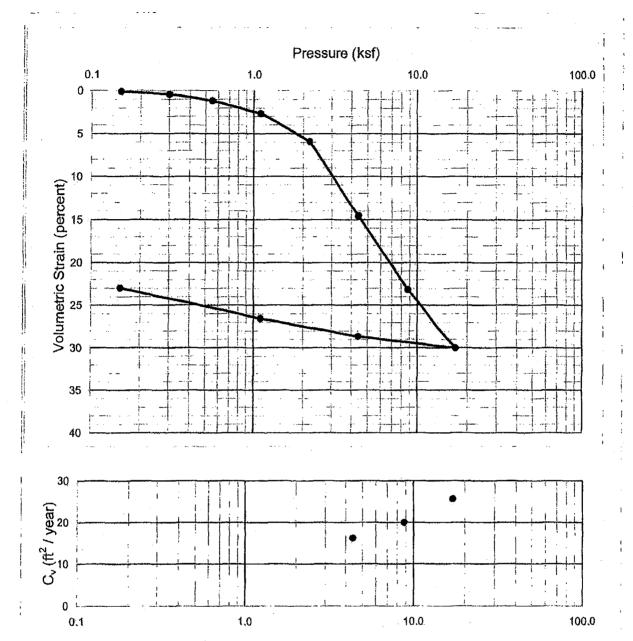
Date 07/19/07 Project No. 4086.17 Figure B-1

Sampler Type: Shelby Tub	e		Condition	Before	Test	f	After Test	. :
	ight (in)	1.00	Water Content	W _a	66,8 %	W _t	43.9	%
Overburden Pressure, po	1,650	psf	Void Ratio	e _o	1.83	e _f	1.18	
Preconsol. Pressure, pc	2,000	psf	Saturation	So	98 %	Sf	100	%
Compression Ratio, C₅c	0.31		Dry Density	$\gamma_{\rm d}$	60 pcf	Ya	77	pcf
Recompression Ratio, Cer	0.04	-			G_{s}	2.70	(assumed)	
Classification CLAY (CH)			S	ource	B32-1 @ 16.	5'		
Block 32 - Miss	ion Bay I	East						
San Francisco	o, Californ	ia		CONSOL	IDATION TE	est r	EPORT

CONSOLIDATION	TEST	REPORT

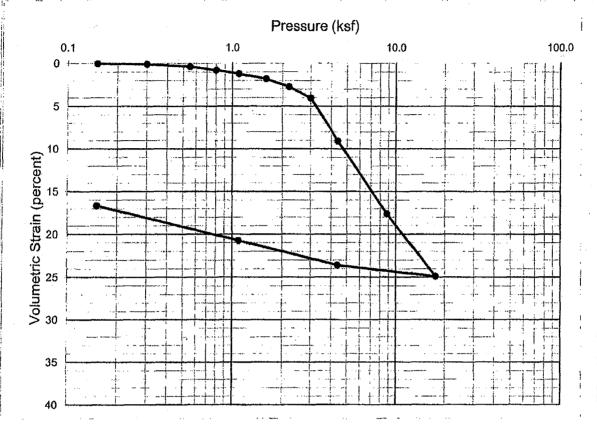
Date 07/26/07 Project No. 4086.17 Figure B-2

Sampler Type: Shelby Tube			Condition	Before	Test	L	After Test	
,		1.01	Water Content	Wo	57.6 %	W_{f}	43.3	%
Overburden Pressure, po	1,900	psf ,	Void Ratio	e	1.56	ef	1.17	[
Preconsol. Pressure, pc	2,900	psf	Saturation	So	100 %	Sr	100	%
Compression Ratio, C _{sc}	0.29		Dry Density	$\gamma_{\rm d}$	66 pcf	γd	78	pcf
Recompression Ratio, Cer	0.05		1	Les parametes .	G_s	2.70	(assumed)	
Classification CLAY (CH),	gray	*****	S	ource	B32-1 @ 24			
Black 32 - Miss	ion Ray F	aet	ì					,

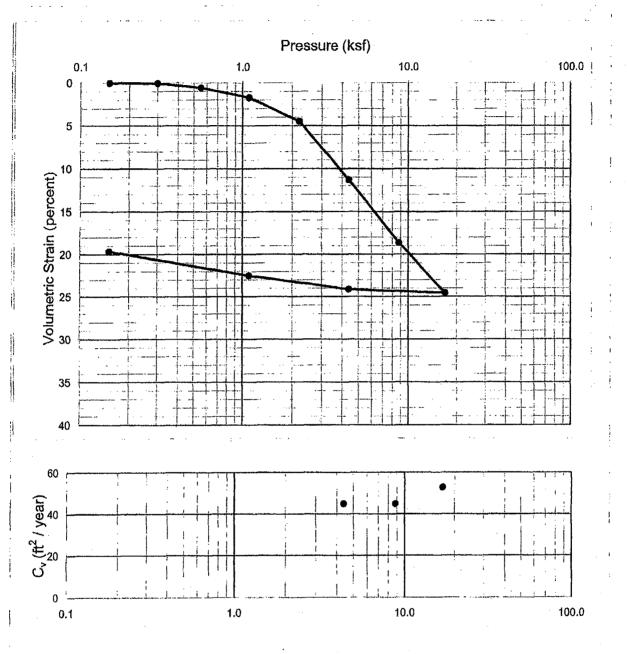
Sampler Type: Shelby Tube	9		Condition	Before	e Test		After Test		
The state of the s	ght (in)	1.00	Water Content	Wo	50.9 %	Wf	35.9 %		
Overburden Pressure, po	1,600	psf	Void Ratio	e _o	1.39	e _i	0.97		
Preconsol. Pressure, pc	2,000	psf	Saturation	¦ S _o	99 %	S	100 %		
Compression Ratio, Ccc	0.25		Dry Density	γ _d	71 pcf	γd	86 pcf		
Recompression Ratio, C	0.03				Gs	2.70	(assumed)		
Classification CLAY (CH),	gray		Sou	rce	B32-3 @ 24'	****			
Block 32 - Miss San Francisco	_			CONSOLIDATION TEST REPORT					
Treadwe	184	los	Date 0	7/26/07 P	roject No. 4	086.17	Figure B-3

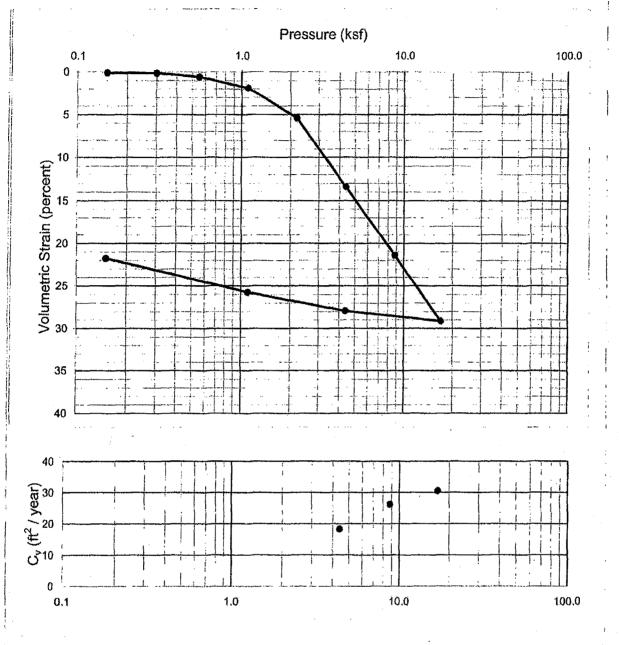
Sampler Type: Shelby Tube		Condition	Before Test				After Test			
Diameter (in) 2.41 Height (in)	1.01	Water Co	ntent	, M	/ ₀	50.9	%	W _f	49.4	%
Overburden Pressure, p. 1,350	psf	Void Ratio	0	, e	0	1.93		Θ,	1.33	
Preconsol. Pressure, p _c 1,700	psf	Saturation	n	ັ້ຽ		100	%	S	100	%
Compression Ratio, C _{sc} 0.28		Dry Dens	ity	γ	d	58	pcf	Ya	72	pcf
Recompression Ratio, C _{cc} 0.05			-	*	••		Gs	2.70	(assumed)	
Classification CLAY (CH), gray			S	Source		B32-4	@ 16	.5'		
B lock 32 - Mission Bay San Francisco, Califo		m 1,14.	CONSOLIDATION TEST REPORT							
Treadwell&	Ro		Date	07/26/0	07	 Project No	. 4	086.17	Figure B	 I-4

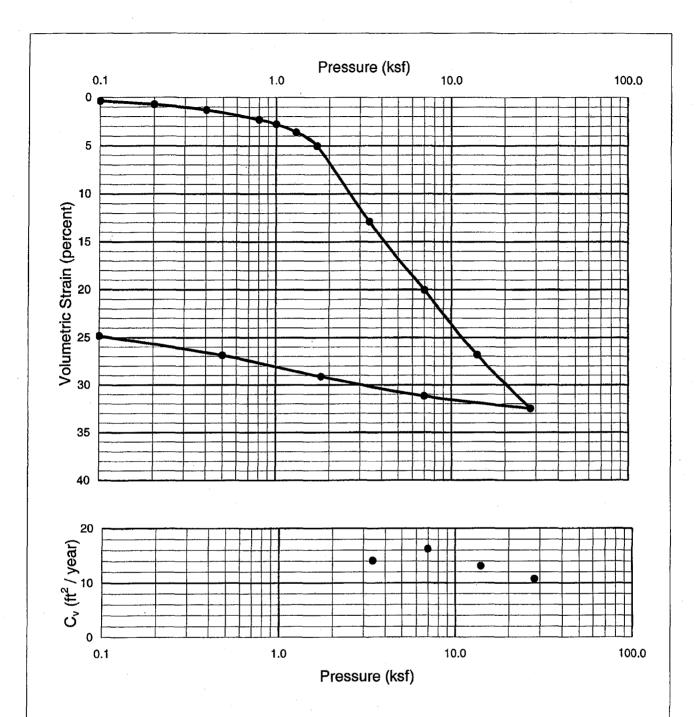
Date 04/02/08 Project No. 3347.01 Figure D-1

Sampler Type: Shelby Tul	oe (ST)		Condition	Befor	e Test		After Test	
Diameter (in) 2.42 Ho	eight (in)	1.00	Water Content	Wo	61.5 %	W _f	39.3	%
Overburden Pressure, po	1,770	psf	Void Ratio	e _o	1.66	et	1.00	
Preconsol. Pressure, pc	1,770	psf	Saturation	S _o	100 %	Sf	100	%
Compression Ratio, C _{εc}	0.24	-	Dry Density	γ _d	64 pcf	γ _d	84	pcf
LL PL			PI		Gs	2.70	(assumed)

LL -- PL -- Pl -- G_s 2.70 Classification SILT (MH), gray Source B31-1 at 20 feet

CONSOLIDATION TEST REPORT

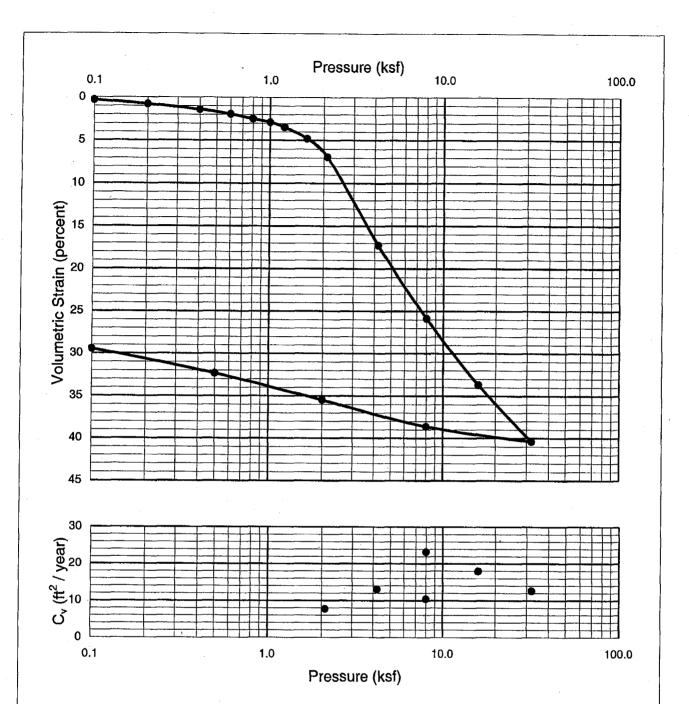
Date 04/02/08 Project No. 3347.01 Figure D-2

Sam	pler Type	: Shelby	Tub	e (ST)		Condition)		Befo	re Test			After Test	
Diam	eter (in)	2.42	He	ight (in)	1.00	Water (Conte	nt	W _o	89.3	%	Wf	56.4	%
Over	burden P	ressure,	ро	2,000	psf	Void Ra	tio		e _o	2.49		e _f	1.46	
Prec	onsol. Pr	essure, p	O _C	2,000	psf	Saturati	on		So	97	%	S _f	100	%
Com	pression	Ratio, C	EC	0.34		Dry Der	sity		Yd	48	pcf	γ _d	69	pcf
LL	79		PL	53			PI	26		,	Gs	2.70	(assumed)	
Class	sification	SILT (N	/H),	gray				Sourc	е	B31-1	at 28	feet

CONSOLIDATION TEST REPORT

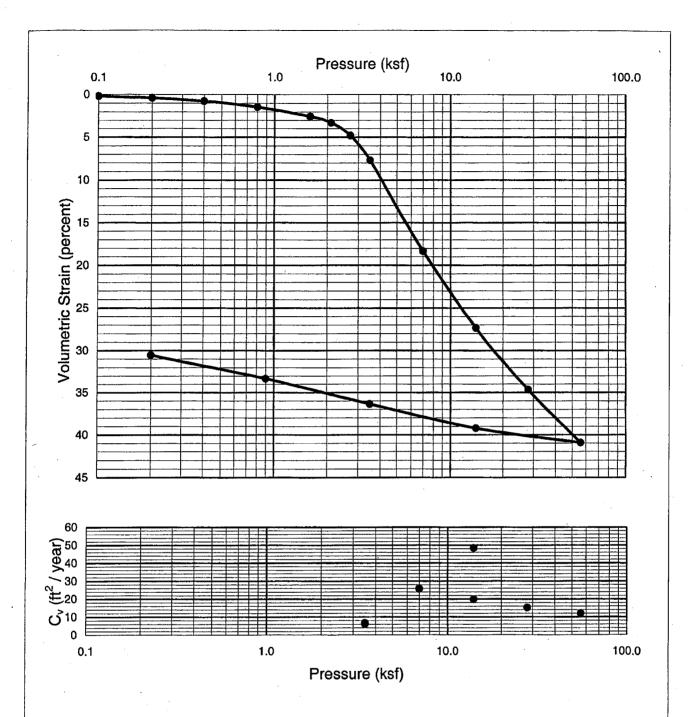
Date 04/02/08 Project No. 3347.01 Figure D-3

Sampler Type: Standard	Penetration	Test	Condition	Befor	re Test		After Test
Diameter (in) 2.42 H	leight (in)	1.00	Water Content	W _o	76.8 %	Wf	43.8 %
Overburden Pressure, p.	2,600	psf	Void Ratio	eo	2.08	Θf	1.14
Preconsol. Pressure, pc	2,900	psf	Saturation	S _o	100 %	St	100 %
Compression Ratio, C _{εc}	0.35		Dry Density	γ _d	55 pcf	γ _d	79 pcf
11			· DI		G	2.70	(accumed)

Classification SILT (MH), gray

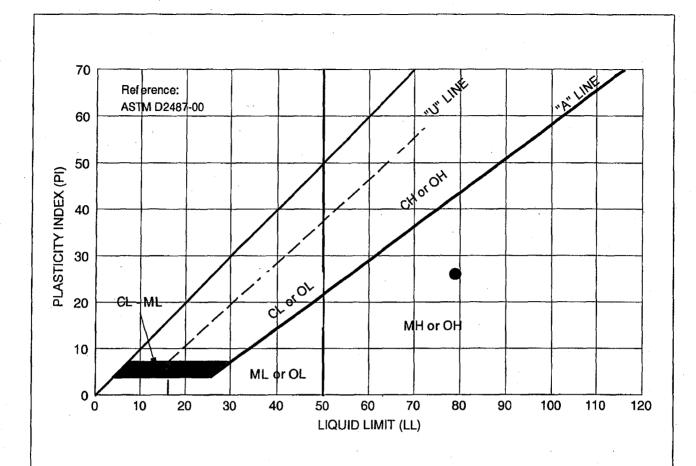
Symbol	Source	Description and Cla	assification	Natural M.C. (%)	Liquid Limit (%)	Plasticitý Index (%)	% Passing #200 Sieve
•	B31-1 at 31 feet	SILT (MH), gray		_	79	26	
·		•					
						Į.	
							,
,							
					,	· . -	·

PLASTICITY CHART
