**GEOTECHNICAL INVESTIGATION
BLOCKS 33 AND 34 PUBLIC IMPROVEMENTS
MISSION BAY
San Francisco, California**

**Catellus
San Francisco, California**

**1 May 2008
Project No. 3349.01**

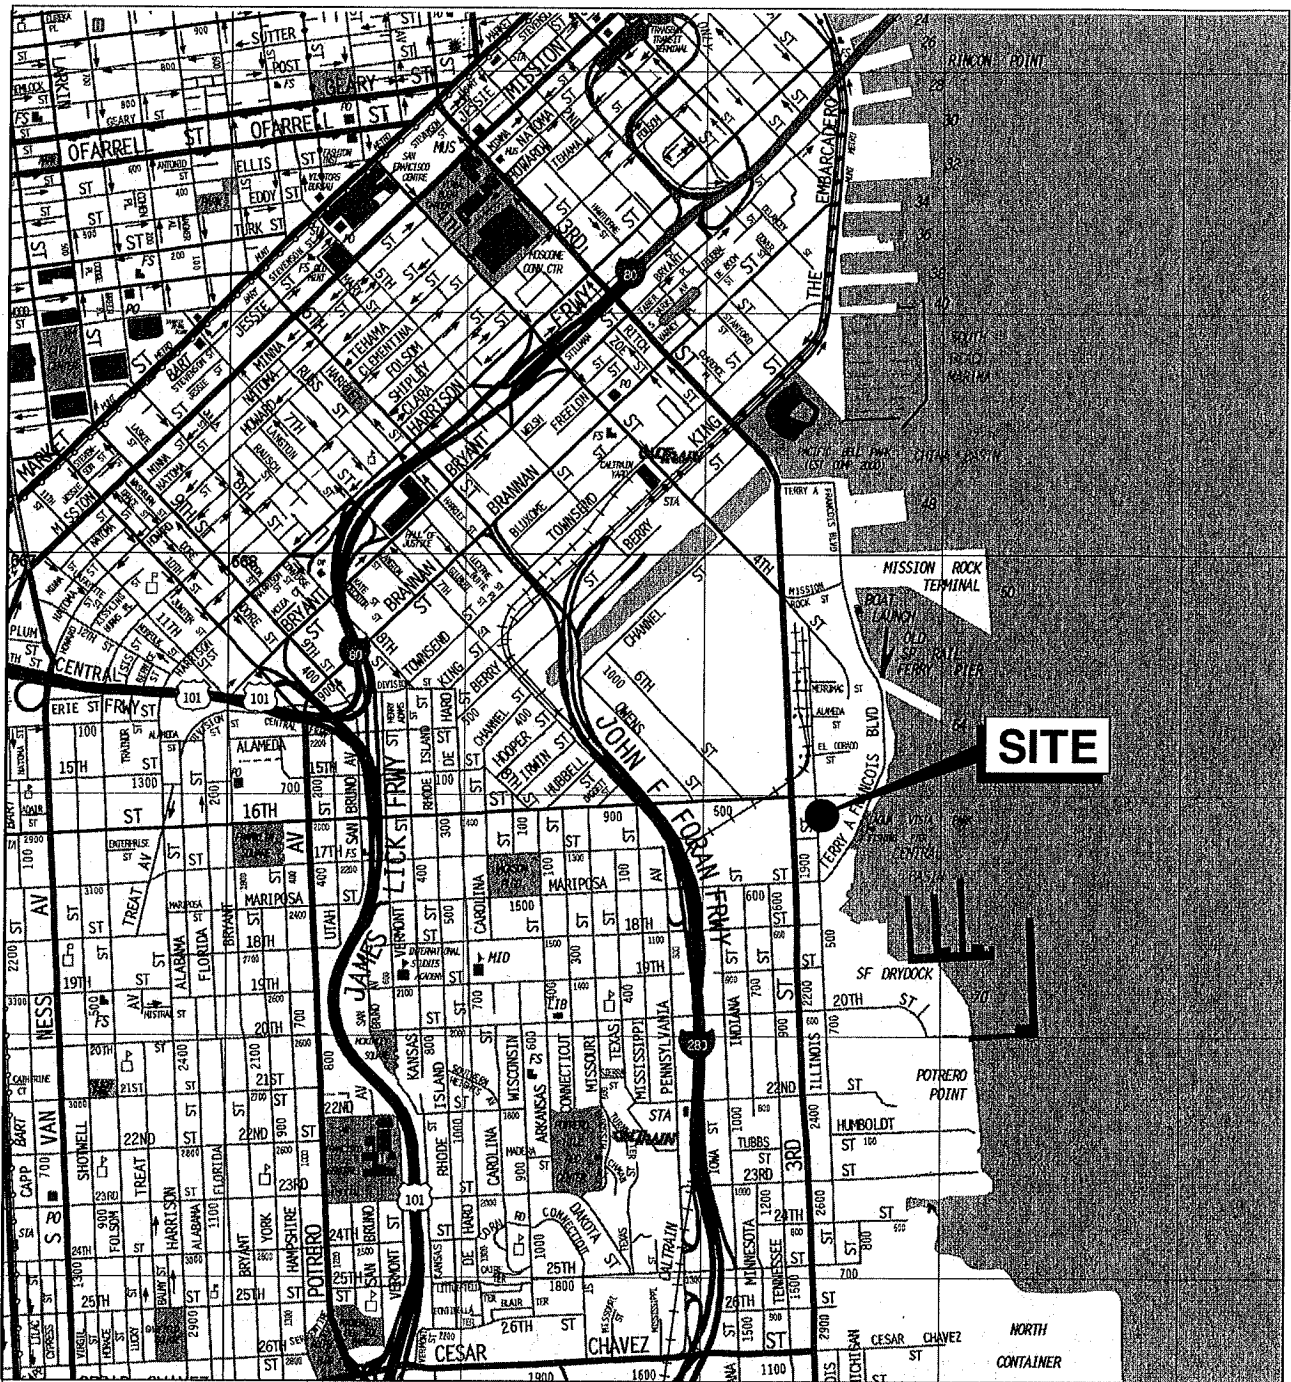
Figure 1

The site location is shown on Figure 1. Based on the project plans, the site is comprised of the north and south sides of 16th Street between Third Street and the proposed Terry Francois Boulevard and Illinois Street between 16th Street and Mariposa Street, as shown on Figure 2. We also understand that temporary pavement with less than a 5-year design life will be constructed at the intersection of 16th Street and Terry Francois Boulevard, as shown on Figure 2. Geotechnical aspects of the project include placement and compaction of fill and structural soil, backfill of utility trenches, installation of light poles, and preparation of new sidewalks and roadway subgrade, with the exception of the sidewalks adjacent to Block X4 on 16th Street and Illinois Street, which are under a separate project (as shown on Sheets C3.1 through C3.4 on the project plans).

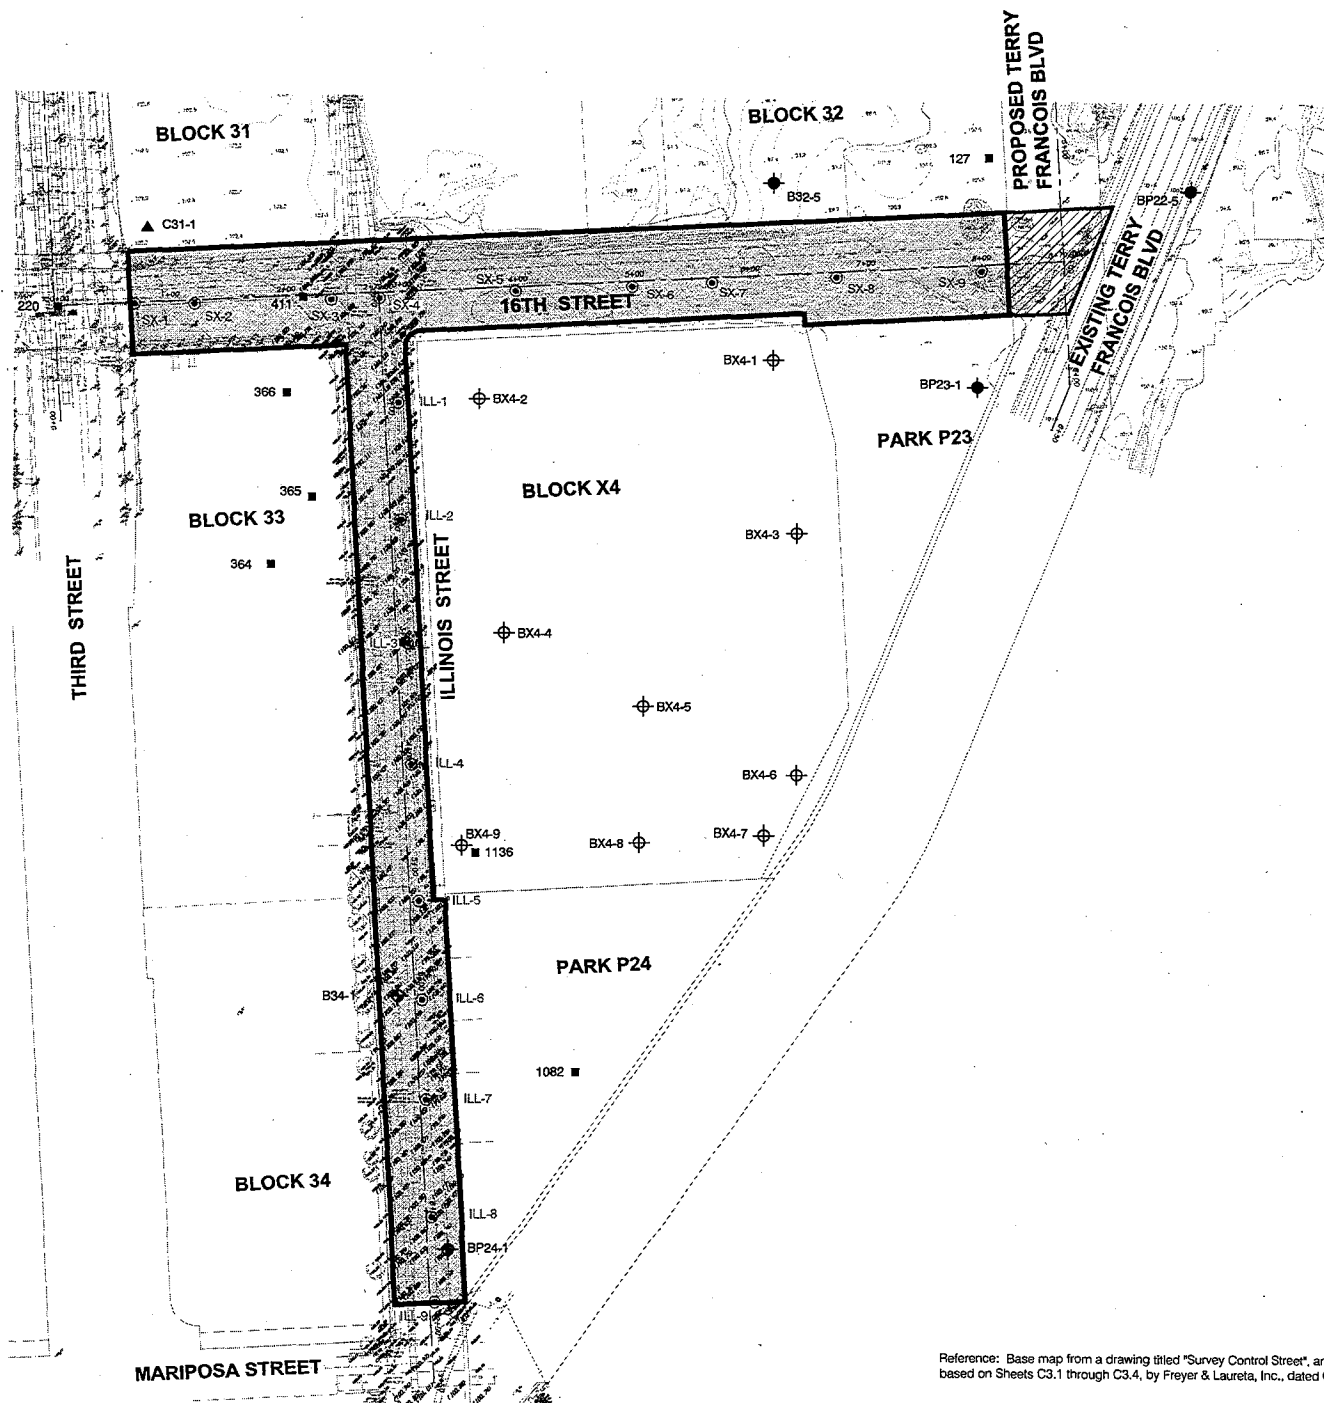
Date 04/30/08 | Project No. 3349.01 | Figure 2

- EXPLANATION**
- BP22-5 ◆ Approximate location of boring by Treadwell & Rollo, Inc., for previous investigation
 - BX4-1 ◆ Approximate location of previous boring by Treadwell & Rollo, Inc., for others (boring logs not included)
 - B34-1 ◆ Approximate location of boring by Treadwell & Rollo, Inc., January 2008
 - C31-1 ▲ Approximate location of cone penetration test by Treadwell & Rollo, Inc., January 2008
 - 366 ■ Borings by others (database designation, boring logs not included)
 - ILL-1 ⊕ Settlement Point
 - Approximate project limits
 - Approximate area of temporary pavement

To supplement the subsurface data available to us, we drilled two test borings as part of our current investigation. The approximate locations of the borings are shown on Figure 2. The logs are presented in Appendix C.

We evaluated site conditions based on our knowledge of the site history and the results of this and previous investigations in the area. Locations of test borings and cone penetration tests performed during this and previous investigations at the site and in the vicinity are shown on Figure 2.

1. Refer to Figure 2 - Site Plan, prepared by Treadwell & Rollo, Inc. for settlement point locations.
2. Mission Bay Infrastructure, Boring Location Plan with Fill Placement History, Project No. 1273-004, Figure 3, Trans Pacific Geotechnical Consultants, Inc., dated 7 July 1993.

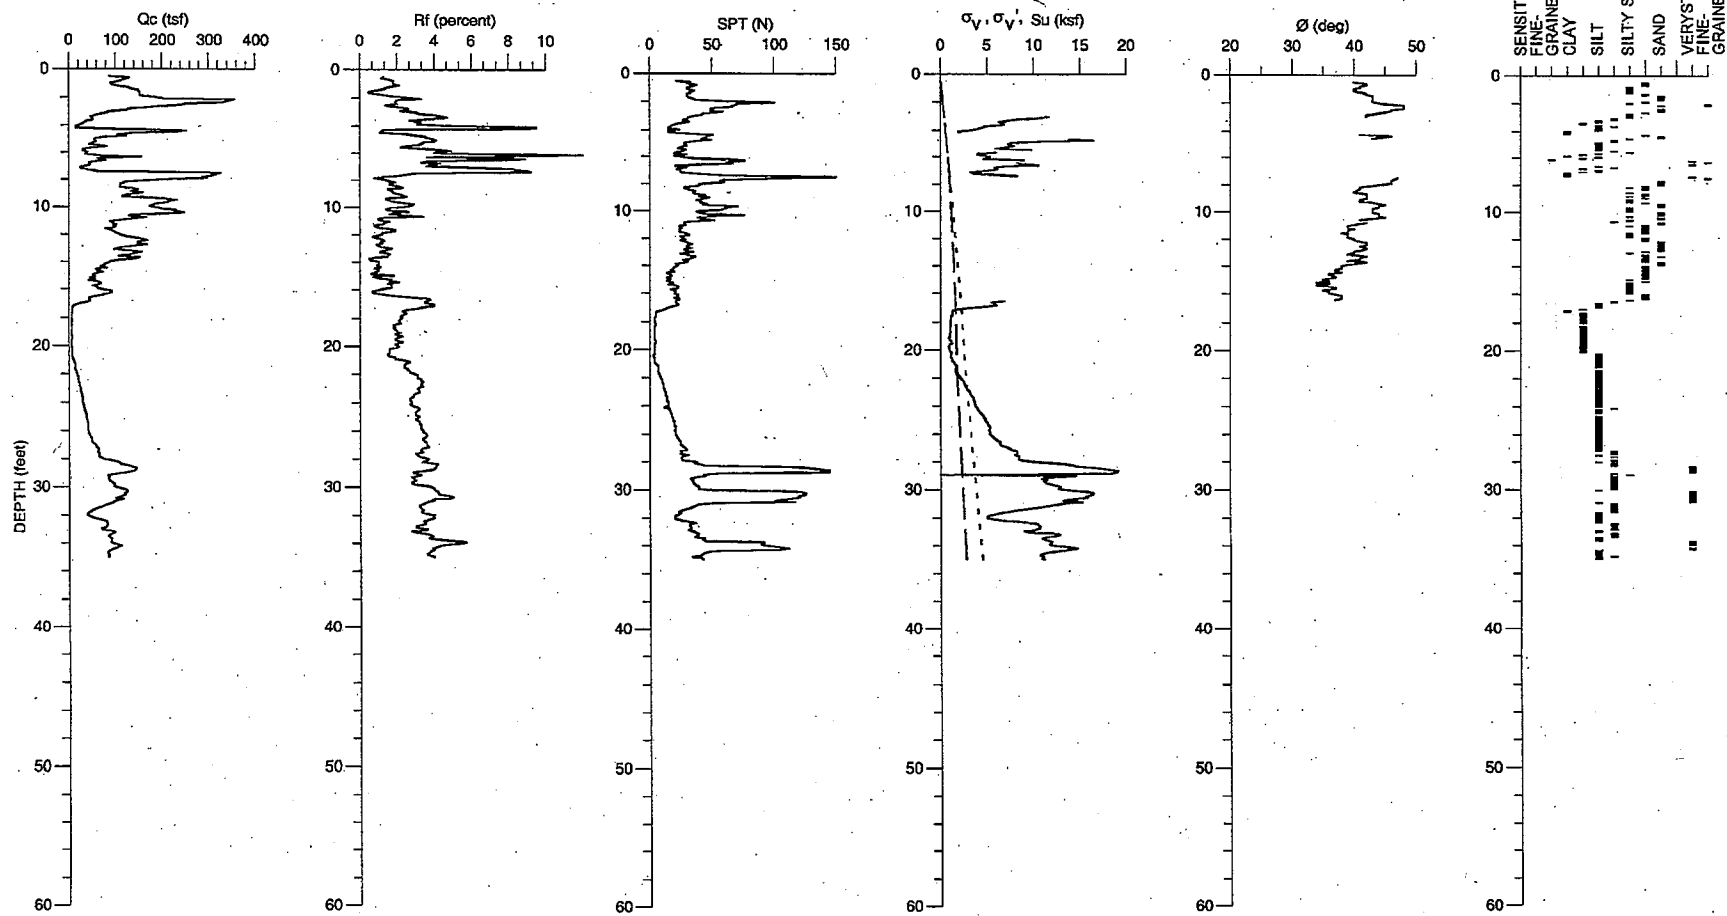
Date 03/20/08 Project No. 3347.01 Figure F-3

Terminated at 35.0 feet.
 Date performed: 1/24/08.
 Ground surface elevation: 102.2 feet, San Francisco City Datum plus 100 feet.

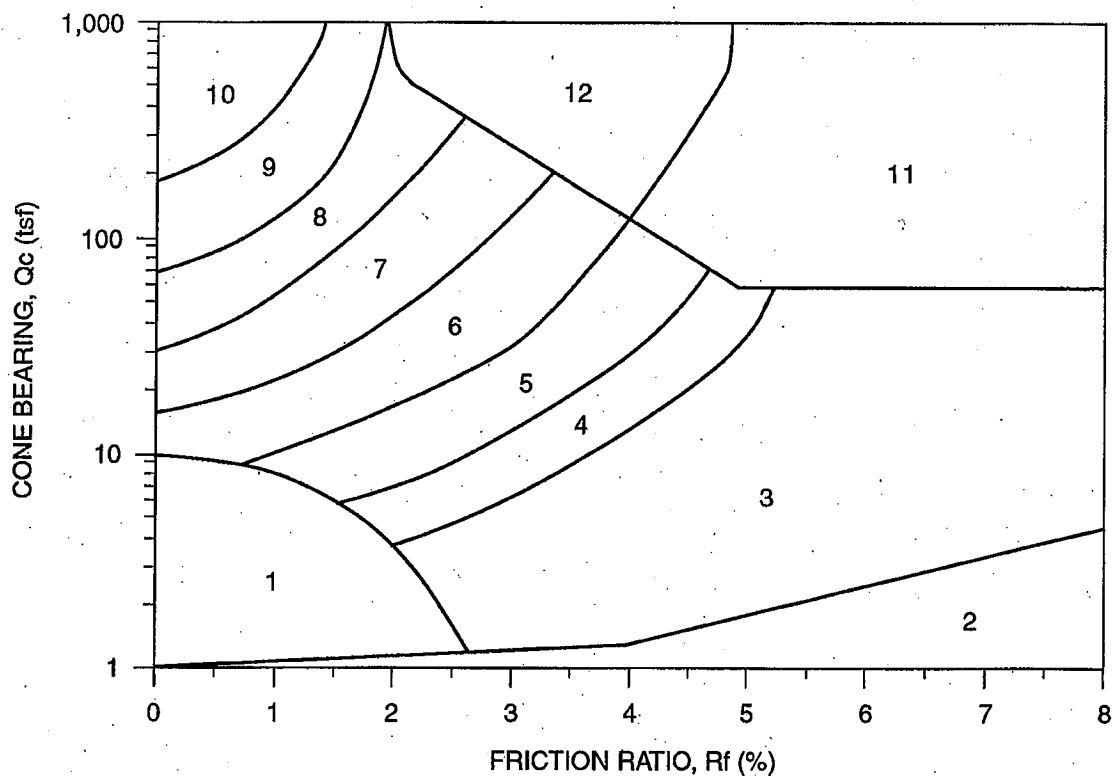
Date 03/20/08 Project No. 3347.01 Figure F-4

ZONE	Q_c/N^1	S_u Factor (Nk) ²	SOIL BEHAVIOR TYPE ¹
1	2	15 (10 for $Q_c \leq 9$ tsf)	Sensitive Fine-Grained
2	1	15 (10 for $Q_c \leq 9$ tsf)	Organic Material
3	1	15 (10 for $Q_c \leq 9$ tsf)	CLAY
4	1.5	15	SILTY CLAY to CLAY
5	2	15	CLAYEY SILT to SILTY CLAY
6	2.5	15	SANDY SILT to CLAYEY SILT
7	3	---	SILTY SAND to SANDY SILT
8	4	---	SAND to SILTY SAND
9	5	---	SAND
10	6	---	GRAVELLY SAND to SAND
11	1	15	Very Stiff Fine-Grained (*)
12	2	---	SAND to CLAYEY SAND (*)

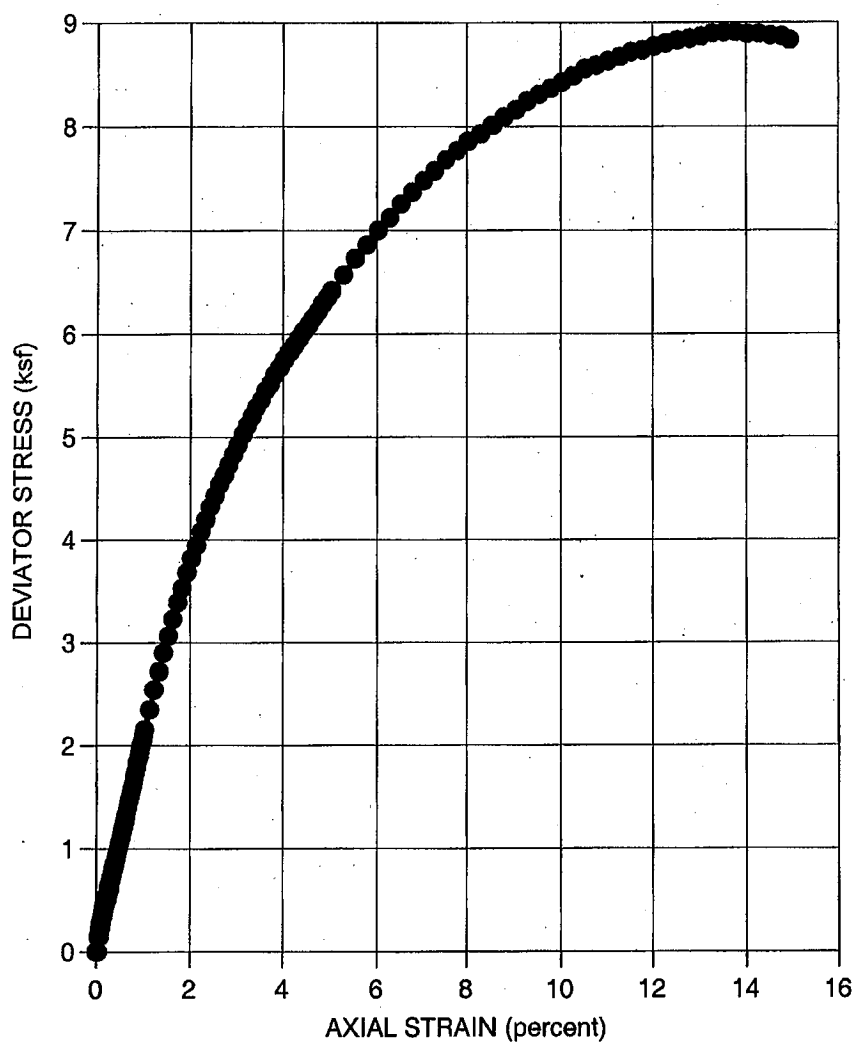
SAMPLER TYPE Sprague & Henwood (S&H)		SHEAR STRENGTH 4,455 psf	
DIAMETER (in) 2.4	HEIGHT (in) 5.1	STRAIN AT FAILURE 13.5 %	
MOISTURE CONTENT 15.7 %		CONFINING PRESSURE 850 psf	
DRY DENSITY 118 pcf		STRAIN RATE 0.99 % /min	
DESCRIPTION CLAYEY SAND with GRAVEL (SC), reddish brown			SOURCE B32-5 at 24.5 feet
BLOCK 32 MISSION BAY San Francisco, California		UNCONSOLIDATED-UNDRAINED TRIAxIAL COMPRESSION TEST	
Treadwell&Rollo		Date 04/14/08	Project No. 3349.01 Figure B-5

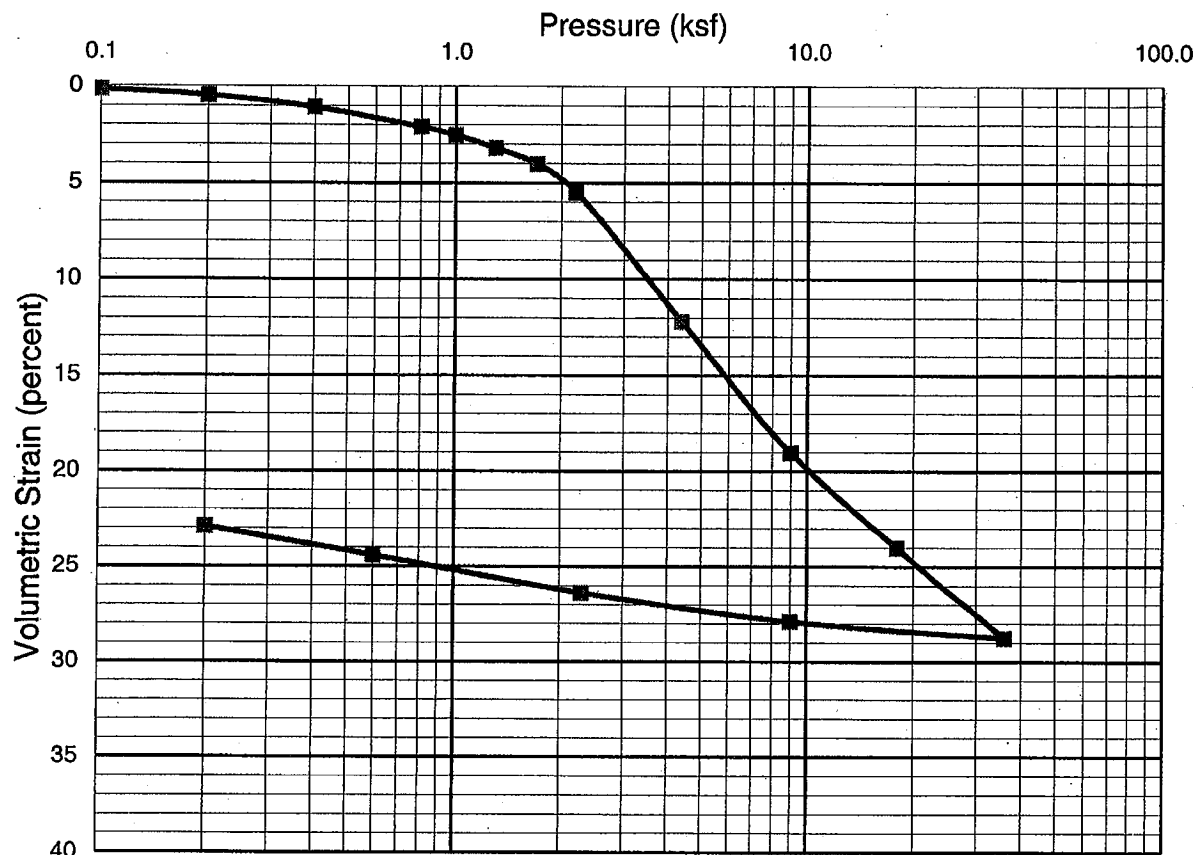
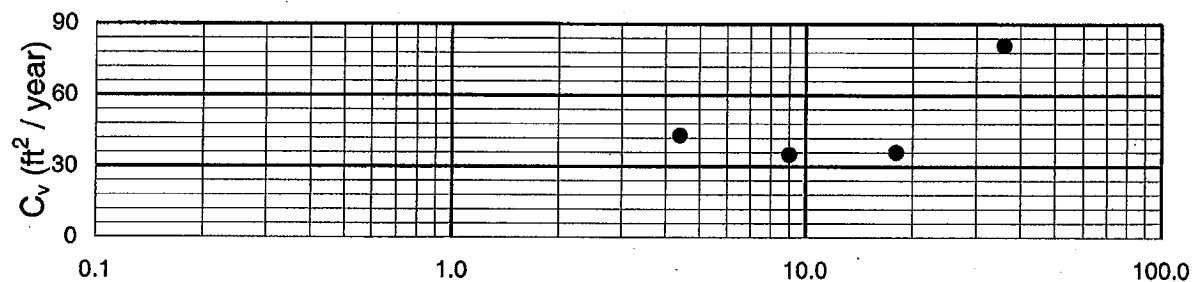
Sampler Type: Shelby Tube (ST)				Condition	Before Test			After Test											
Diameter (in)		2.42		Height (in)		1.00		Water Content		w _o	47.3 %		w _f	29.8 %					
Overburden Pressure, p _o				1,200		psf		Void Ratio		e _o	1.31		e _f	0.78					
Preconsol. Pressure, p _c				2,000		psf		Saturation		S _o	98 %		S _f	100 %					
Compression Ratio, C _{ec}				0.22				Dry Density		γ _d	73 pcf		γ _d	95 pcf					
LL		--		PL		--		PI		--		G _s		2.70 (assumed)					
Classification CLAY (CH), olive gray								Source B34-1 at 12 feet											
BLOCKS 33-34 PUBLIC IMPROVEMENTS MISSION BAY San Francisco, California								CONSOLIDATION TEST REPORT											
Treadwell & Rollo								Date		04/29/08		Project No.		3349.01		Figure		D-1

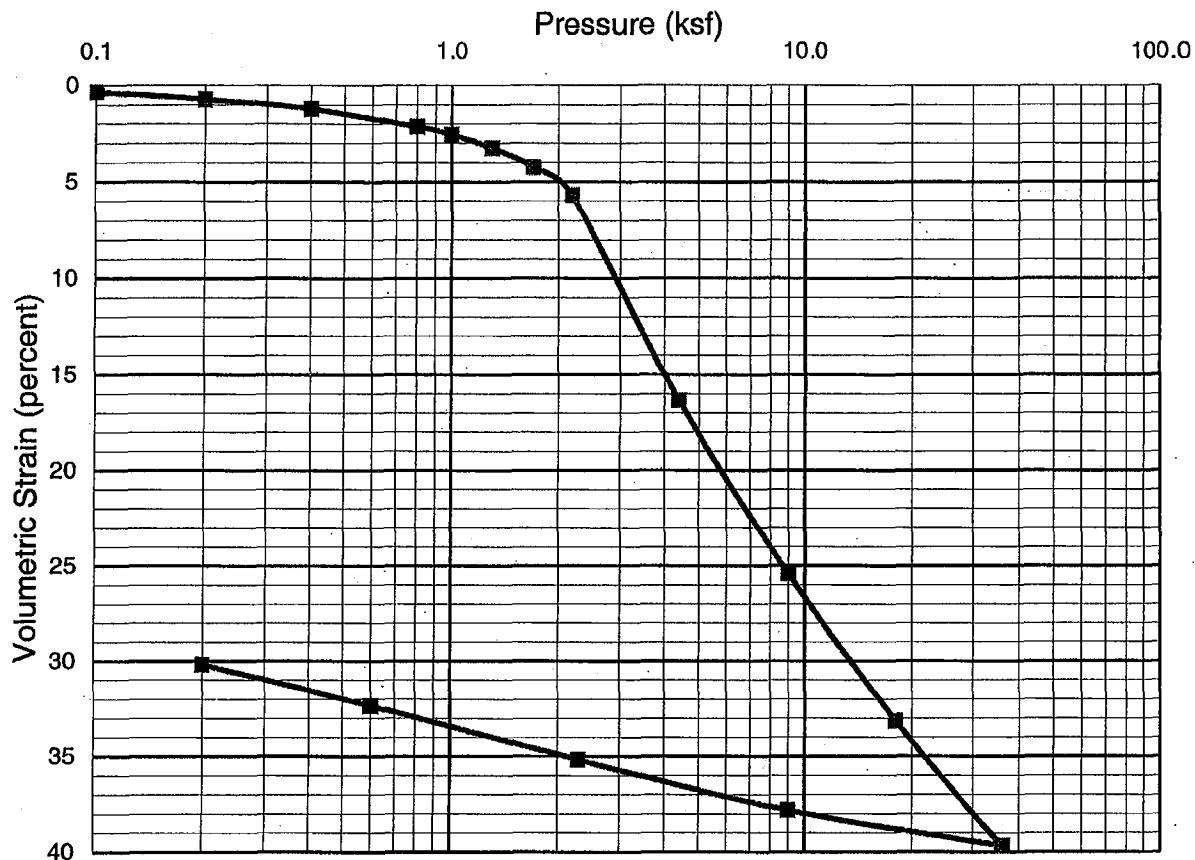
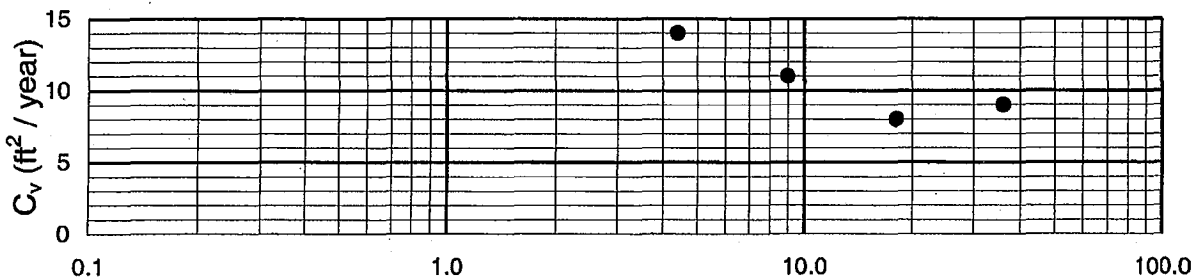
Sampler Type: Shelby Tube (ST)		Condition		Before Test		After Test	
Diameter (in)	2.42	Height (in)	1.00	Water Content	w_o 84.9 %	w_f 50.3 %	
Overburden Pressure, p_o	1,600 psf			Void Ratio	e_o 2.41	e_f 1.38	
Preconsol. Pressure, p_c	2,100 psf			Saturation	S_o 95 %	S_f 98 %	
Compression Ratio, C_{ec}	0.35			Dry Density	γ_d 49 pcf	γ_d 71 pcf	
LL --	PL --	PI --		G_s	2.70 (assumed)		
Classification CLAY (CH), gray				Source BP24-1 at 19 feet			
BLOCK 33-34 PUBLIC IMPROVEMENTS MISSION BAY San Francisco, California				CONSOLIDATION TEST REPORT			
Treadwell & Rollo				Date	04/29/08	Project No.	3349.01
				Figure D-2

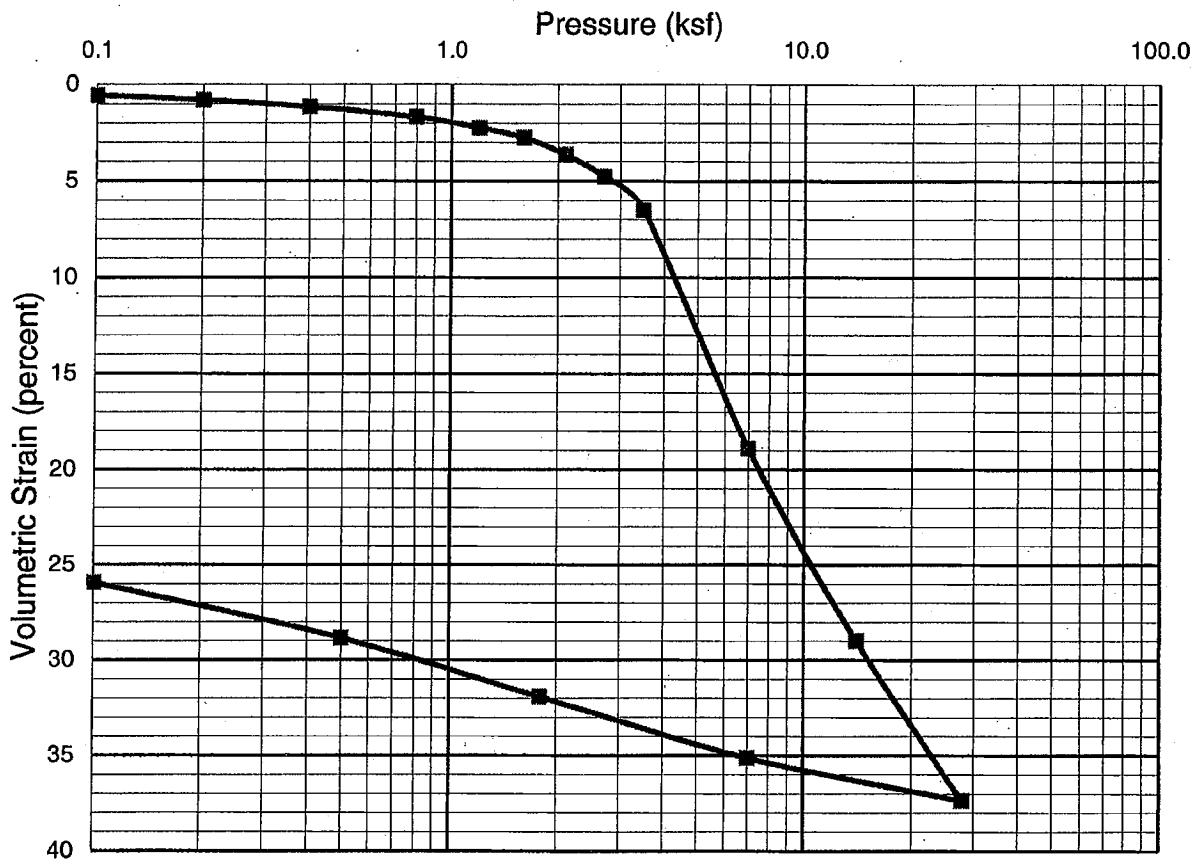
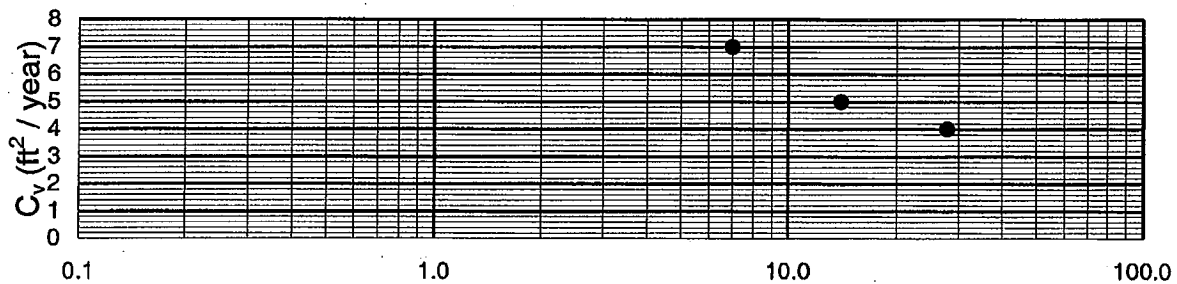
Sampler Type: Shelby Tube (ST)		Condition		Before Test		After Test	
Diameter (in)	2.42	Height (in)	1.00	Water Content	w_o	88.3 %	w_f 58.1 %
Overburden Pressure, p_o	1,900	psf		Void Ratio	e_o	2.47	e_f 1.57
Preconsol. Pressure, p_c	3,300	psf		Saturation	S_o	96 %	S_f 100 %
Compression Ratio, C_{ec}	0.41			Dry Density	γ_d	49 pcf	γ_d 66 pcf
LL	--	PL	--	PI	--	G_s	2.70 (assumed)
Classification Olive gray silty clay				Source BP24-1 at 27 feet			
BLOCK 33-34 PUBLIC IMPROVEMENTS MISSION BAY San Francisco, California				CONSOLIDATION TEST REPORT			
Treadwell & Rollo				Date	04/29/08	Project No.	3349.01
						Figure	D-3
